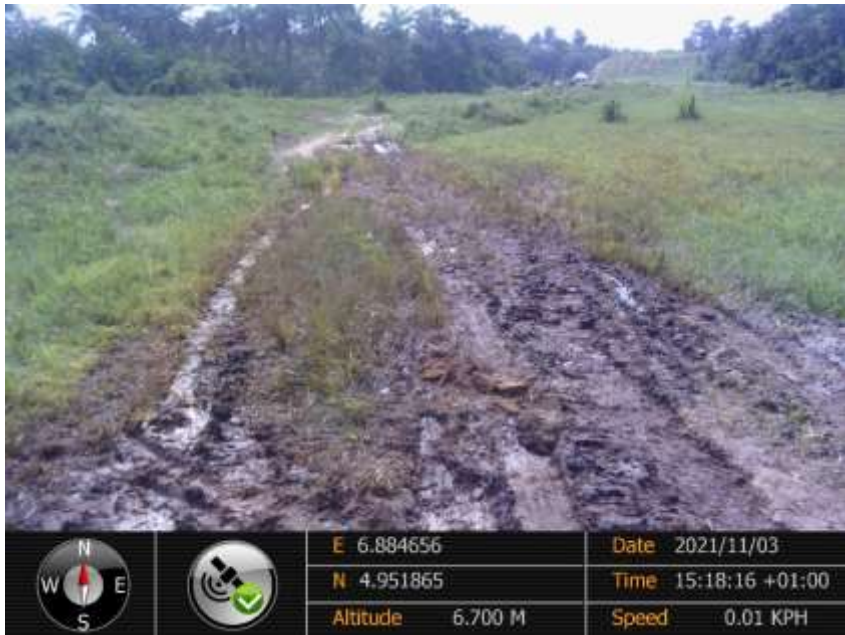
Overview: Part of spill impact on 20'' Rumuekpe Nkpoku Pipeline at Adanta Isiokpo.  
Picture was taken during Joint Investigation of 3<sup>rd</sup> November 2021.

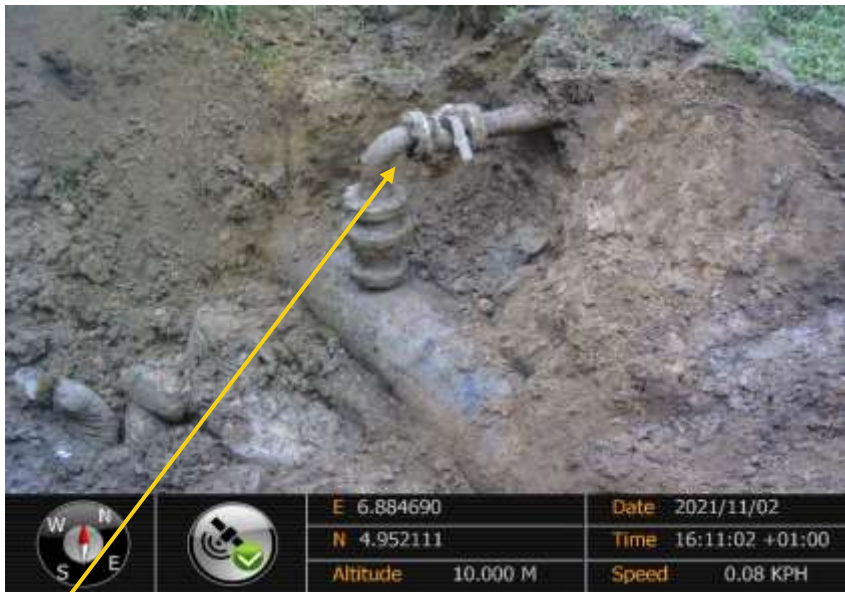
Close-up: 6''x 4'' ball valve installed at 12 o'clock position and fitted to 4'' extension pipe on 20'' Rumuekpe Nkpoku Pipeline at Adanta Isiokpo.  
Picture was taken during Joint Investigation of 2<sup>nd</sup> November 2021.
