# JOINT INVESTIGATION REPORT

INCIDENT NO: 3060687 JIV report S/N: 0000990

1. Fountain Incident Number: 3060687 2. Type of incident\* OIL SPILL  
3. Name of Location 16" NUN RIVER - KOLE CREEK PIPELINE  
4. Name of nearest community AGUOBIRI 5. State: BAYELSA 6. LGA SOUTHERN-IJAW  
7. Production Facility/Installation OIL PIPELINE  
8. Asset Owner/Hub THE SHELL PETROLEUM DEVELOPMENT COMPANY OF NIGERIA LIMITED (SPDC)/PIPELINE

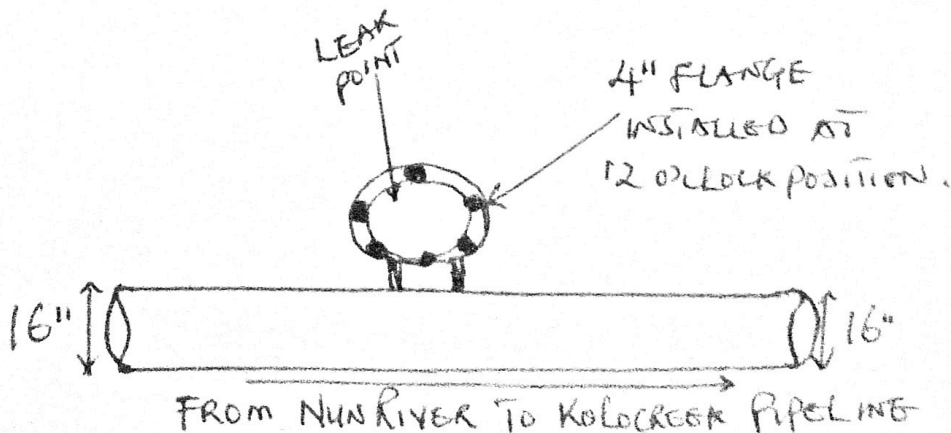
**E. GRAPHIC DESCRIPTION OF LEAK POINT** (while detailed description of the leak point should be contained in the leak report, overview sketch of the site should be added as appendix 1) A SECTION OF 16" NUN RIVER - KOLDCREEK PIPELINE AT AGUOBIRI SHOWING A 4" FLANGE INSTALLED AT 12 O'CLOCK POSITION DONE BY UNKNOWN PERSONS.
