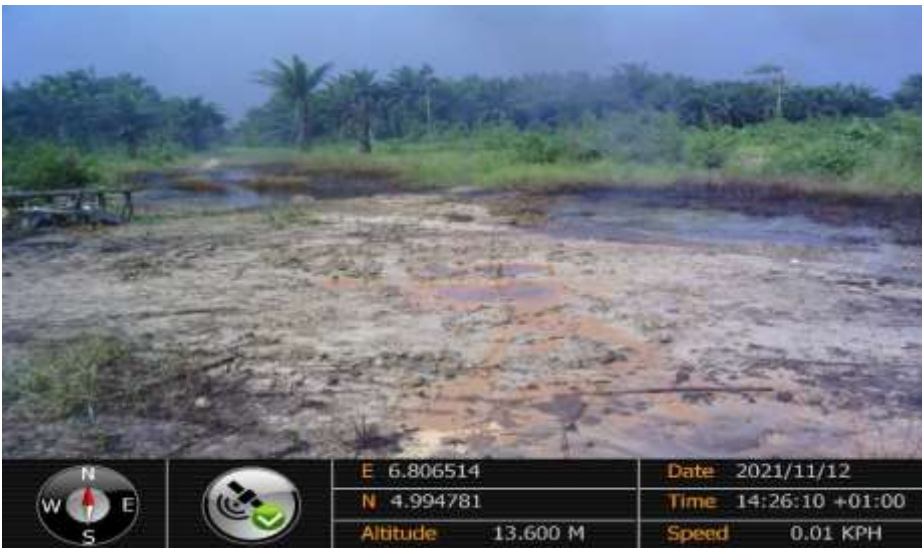
Overview: Part of spill impact on 4" Obelle Ibaa Deliveryline at Ibaa. Picture was taken during Joint Investigation of 12th November 2021.

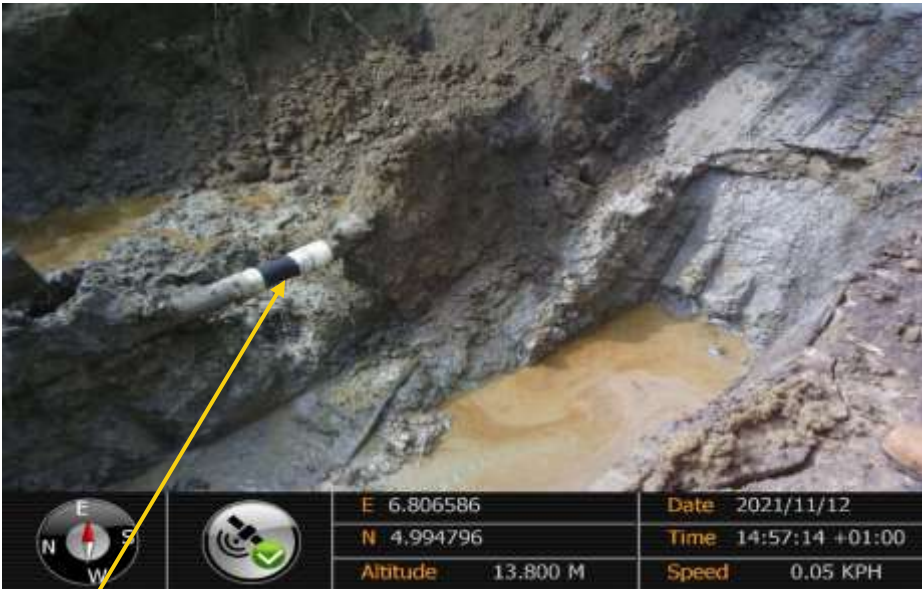
Close-up: Hack saw cut at 6 o'clock position with an arc distance of 90mm on 4" Obelle Ibaa Deliveryline at Ibaa. Picture was taken during Joint Investigation of 12th November 2021.
