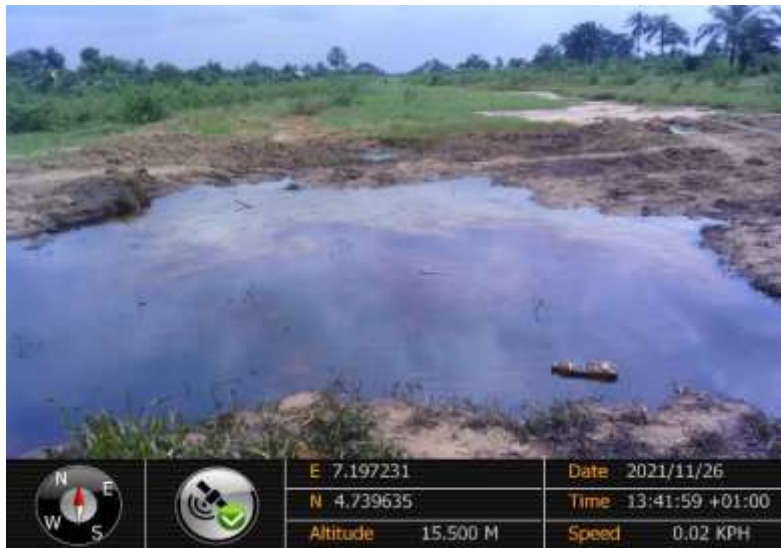
Overview: Part of spill impact on 28" Ogale Bomu Pipeline at Nonkpor\_Bara-Ale. Picture was taken during Joint Investigation of 26<sup>th</sup> November 2021.

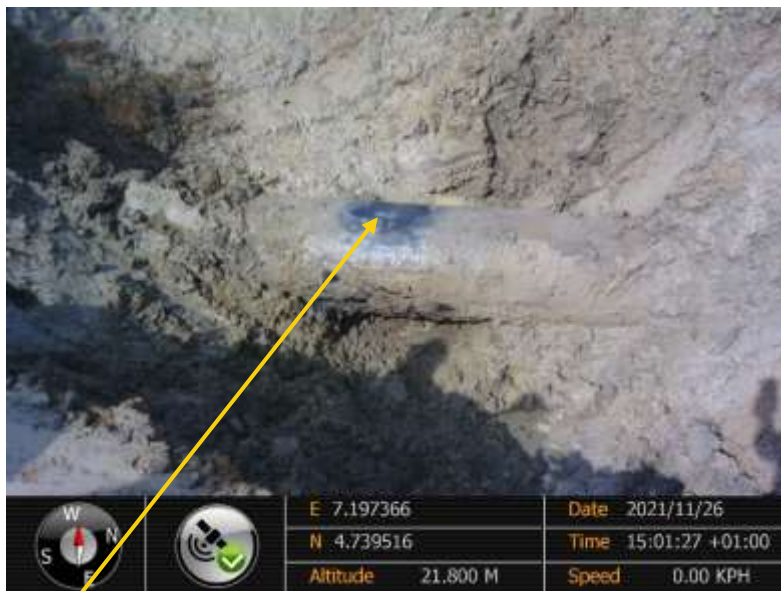
Close-up: Inward dent with thin hole at 12 o'clock position on 28" Ogale Bomu Pipeline at Nonkpor\_Bara-Ale. Picture was taken during Joint Investigation of 26<sup>th</sup> November 2021.
