JOINT INVESTIGATION REPORT

INCIDENT NO: 3059974 JIV report S/N: 0000981

1. Fountain Incident Number: 3059974 2. Type of incident* OIL SPILL
3. Name of Location 18" ASSA - RUMMERPE PIPELINE
4. Name of nearest community UMUDI OGA 5. State: RIVERS 6. LGA EMOHUA
7. Production Facility/Installation CRUDE OIL PIPELINE
8. Asset Owner/Hub THE SHELL PETROLEUM DEVELOPMENT COMPANY
OF NIGERIA LIMITED / PIPELINE

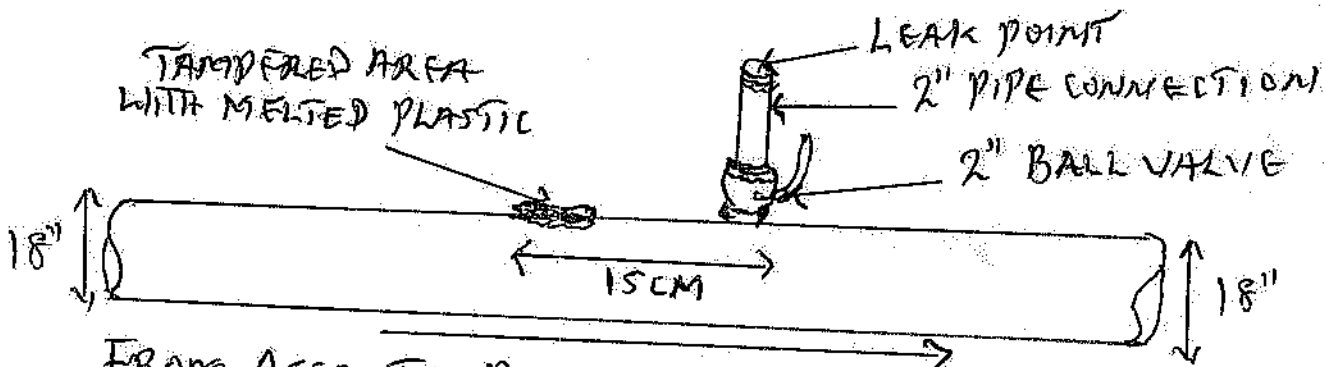
LONG STRETCH OF AN EXCAVATED TRENCH WAS OBSERVED.

| <input checked="" type="checkbox"/> Failed Weld-on illegal hot tap valve | <input type="checkbox"/> Failed Clamp, | <input type="checkbox"/> Missing Pipeline/Flowline |
| <input checked="" type="checkbox"/> Crude oil theft (illegal bunkering) point, | <input type="checkbox"/> Saver-pit over flow | <input type="checkbox"/> Third party tampering with Clamp |

SECTION OF 18" ASSA - RUMUKEYE PIPELINE AT UMUDIOGA SHOWING CRUDE OIL LEAK POINT AND TAMPERED AREA BY UNKNOWN PERSON(S).

FROM ASSA TO RUMUKEYE

OIL SPILL RESPONSE AND REPAIR ACTIVITIES ARE ONGOING.
