JOINT INVESTIGATION REPORT

INCIDENT NO: 3070238 JIV report S/N: 0001020

1. Fountain Incident Number: 3070238 2. Type of incident* OIL SPILL
3. Name of Location 4" OTUMARA WELL 29S FLOWLINE
4. Name of nearest community OTUMARA 5. State: DELTA 6. LGA WARRI SOUTH WEST
7. Production Facility/Installation FLOW LINE
8. Asset Owner/Hub THE SHELL PETROLEUM DEVELOPMENT COMPANY NIGERIA LIMITED / SWAMP WEST

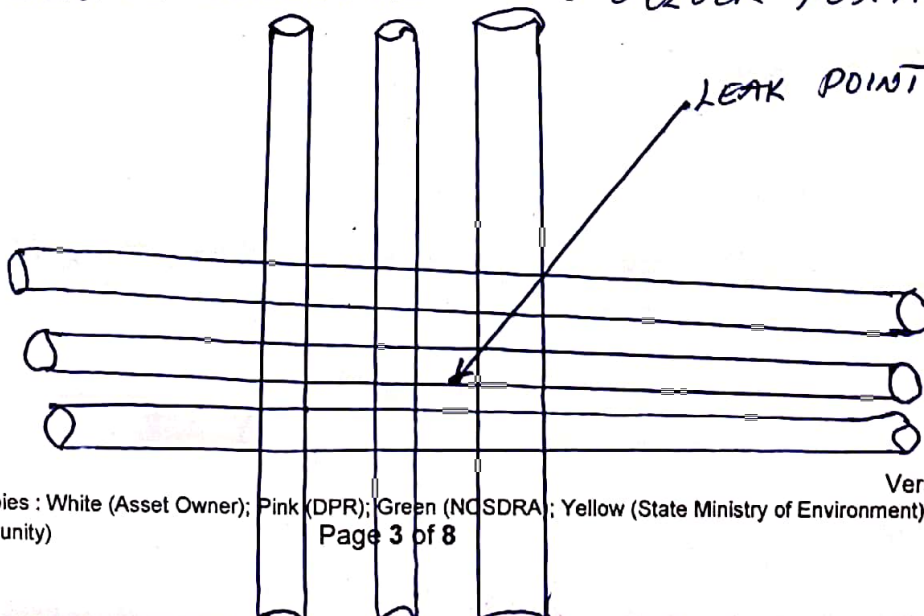
| <input checked="" type="checkbox"/> Others (specify) <u>PIM HOLE DUE TO CORROSION</u> | | |

A SECTION OF 4" OTUMARA WELL 295 FLOWLINE AT OTUMARA SHOWING PIN HOLE DUE TO CORROSION AT 6 O'CLOCK POSITION.
