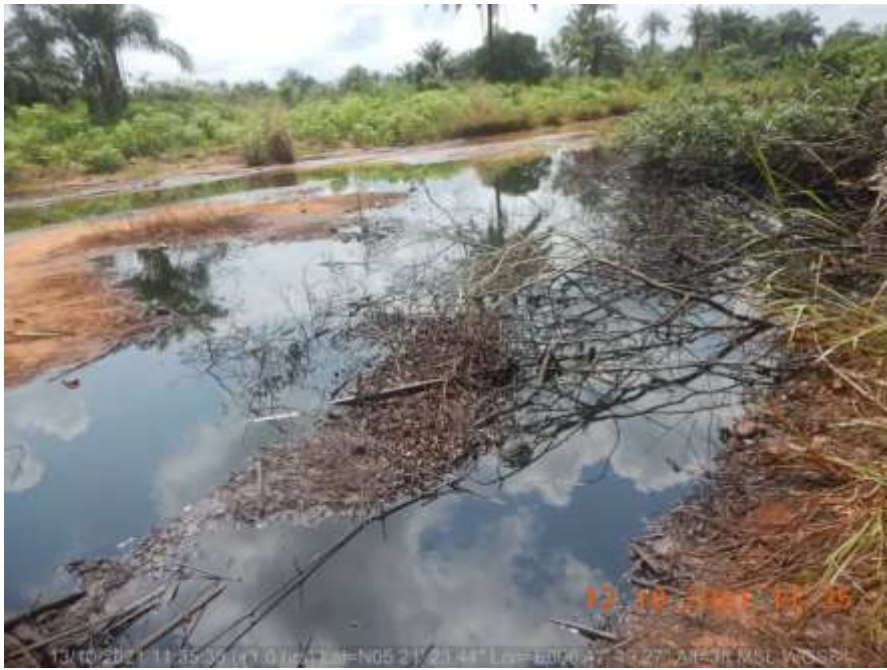
Overview: Part of spill impact on 18" Assa Rumuekpe Pipeline at Ochia.
Picture was taken during Joint Investigation of 13th October 2021.

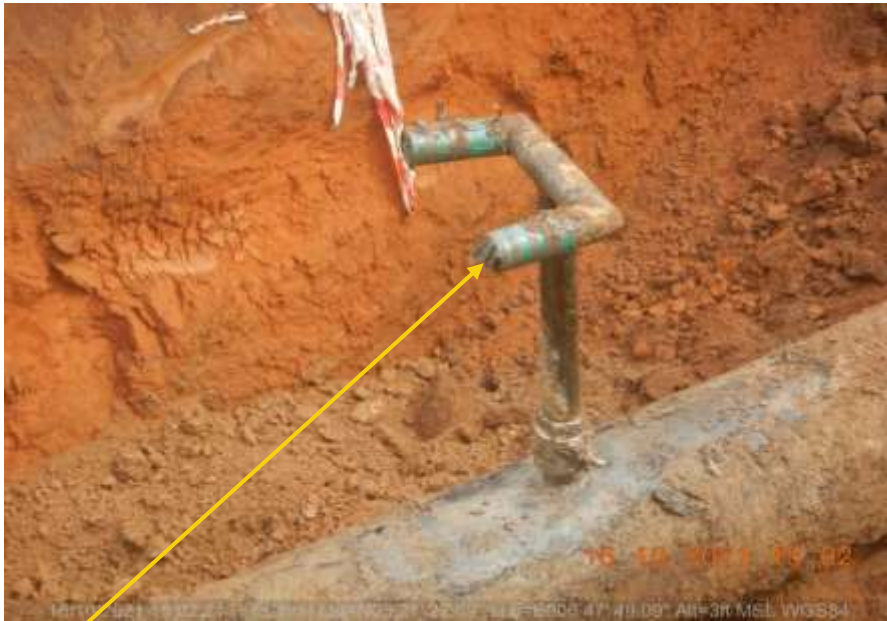
Close-up: Crude oil theft point installed at 12 o'clock position on 18" Assa Rumuekpe Pipeline at Ochia. Picture was taken during Joint Investigation of 13th October 2021.
