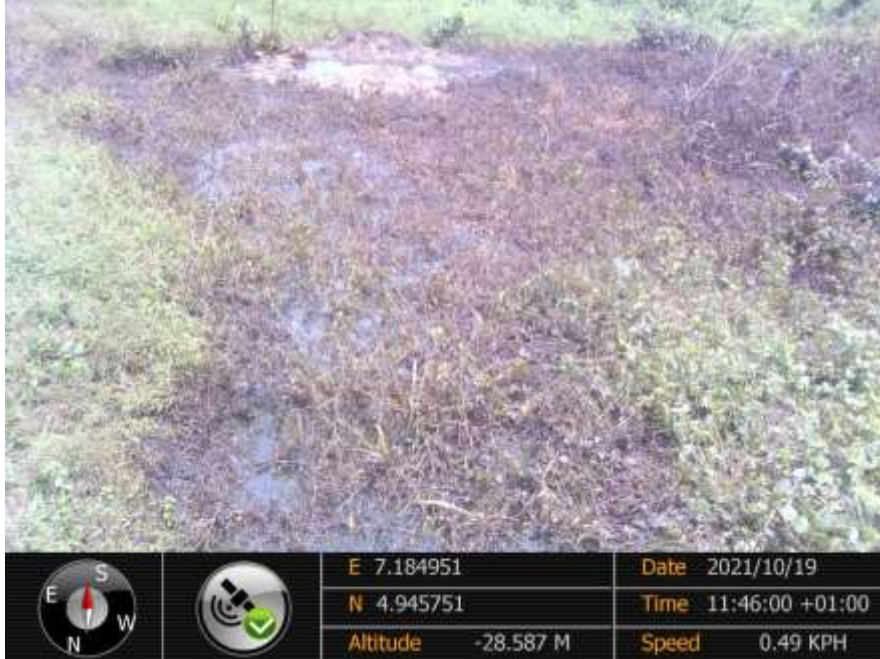
Overview: Part of spill impact on 12" Imo river 1- Ogale Pipeline at Umulolo. Picture was taken during Joint Investigation of 19th October 2021.

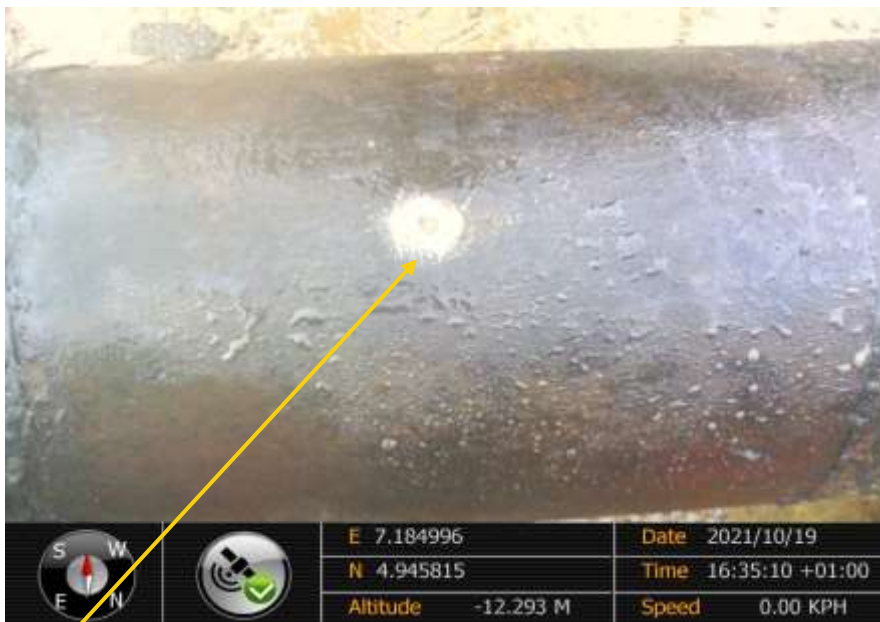
Close-up: 5mm smooth round edge hole at 12 o'clock position on 12" Imo river 1- Ogale Pipeline at Umulolo. Picture was taken during Joint Investigation of 19th October 2021.
