# JOINT INVESTIGATION REPORT

INCIDENT NO: 3046761 JIV report S/N: 0000925

1. Fountain Incident Number: 3046761 2. Type of incident\* OIL SPILL  
3. Name of Location 20" RUMUEKPE - NKPOKU PIPELINE  
4. Name of nearest community ADANIA ISIOKPO 5. State: RIVERS 6. LGA IKWERRE  
7. Production Facility/Installation OIL PIPELINE  
8. Asset Owner/Hub THE SHELL PETROLEUM DEVELOPMENT COMPANY OF NIGERIA LIMITED (SPDC)/PIPELINE

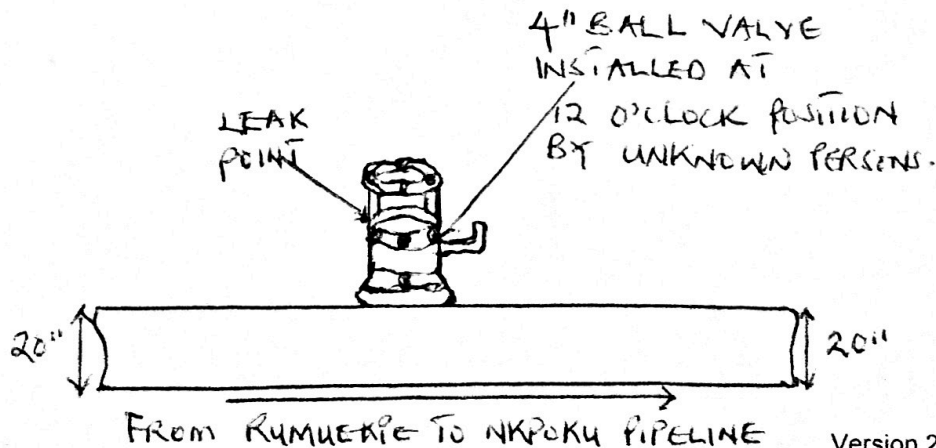
| <input checked="" type="checkbox"/> Failed Weld-on illegal hot tap valve | <input type="checkbox"/> Failed Clamp, | <input type="checkbox"/> Missing Pipeline/Flowline |
| <input checked="" type="checkbox"/> Crude oil theft (illegal bunkering) point, | <input type="checkbox"/> Saver-pit over flow | <input type="checkbox"/> Third party tampering with Clamp |

**E. GRAPHIC DESCRIPTION OF LEAK POINT** (while detailed description of the leak point should be contained in the leak report, overview sketch of the site should be added as appendix 1) A SECTION OF 20" RUMUEKE NKPOKU PIPELINE AT ADANIA-USIGPO SHOWING A 4" BALL VALVE INSTALLED AT 12 O'CLOCK POSITION BY UNKNOWN PERSONS.

REPAIR ACTIVITIES ONGOING

i. Joint investigation of the incident site found that there is no residual impact after the initial response and JIT therefore recommend that the site be closed out <input type="checkbox"/>
ii. Investigation of the incident site showed that there is residual impact on site requiring further works <input checked="" type="checkbox"/>
