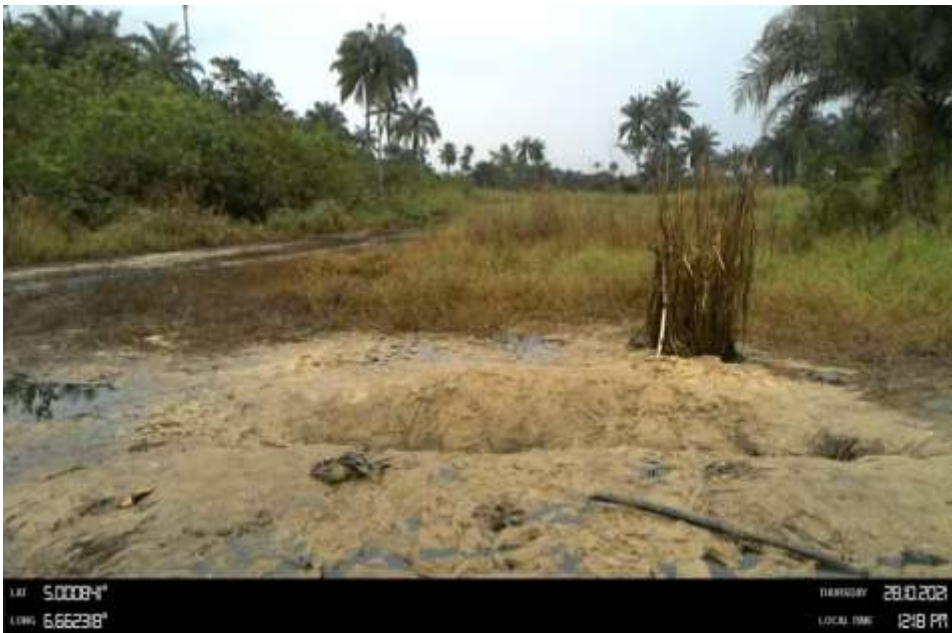
Overview: Part of spill impact on 14" Okordia Rumuekpe Pipeline at Ihuowo. Picture was taken during Joint Investigation of 28<sup>th</sup> October 2021.

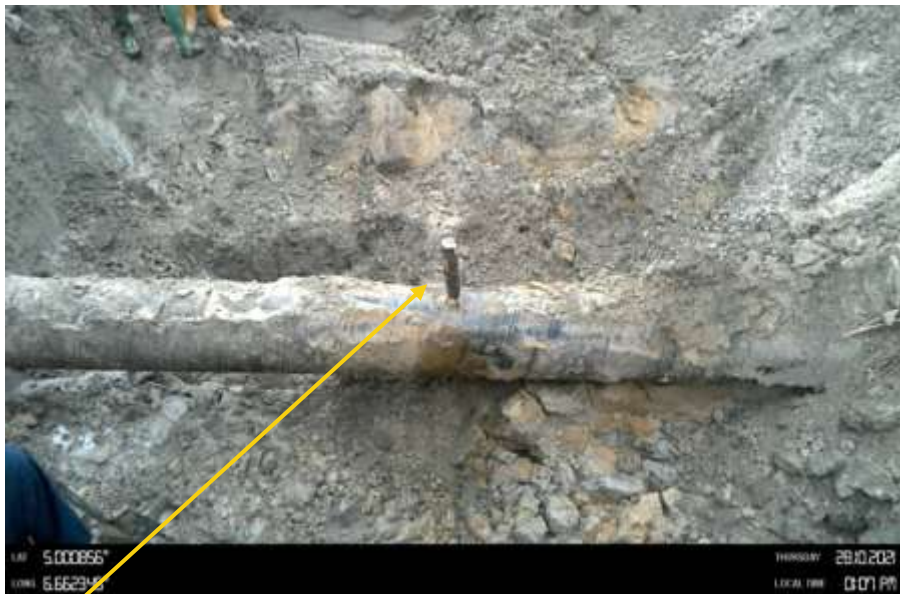
Close-up: Plugged 40mm smooth round edge hole at 12 o'clock position on 14" Okordia Rumuekpe Pipeline at Ihuowo. Picture was taken during Joint Investigation of 28<sup>th</sup> October 2021.
