# JOINT INVESTIGATION REPORT

INCIDENT NO: 3043922 JIV report S/N: 0000989

1. Fountain Incident Number: 3043922 2. Type of incident\* OIL SPILL  
3. Name of Location 14" OKORDIA - RUMUEKPE PIPELINE  
4. Name of nearest community IHYOWO 5. State: RIVERS 6. LGA AHADA - EAST  
7. Production Facility/Installation OIL PIPELINE  
8. Asset Owner/Hub THE SHELL PETROLEUM DEVELOPMENT COMP

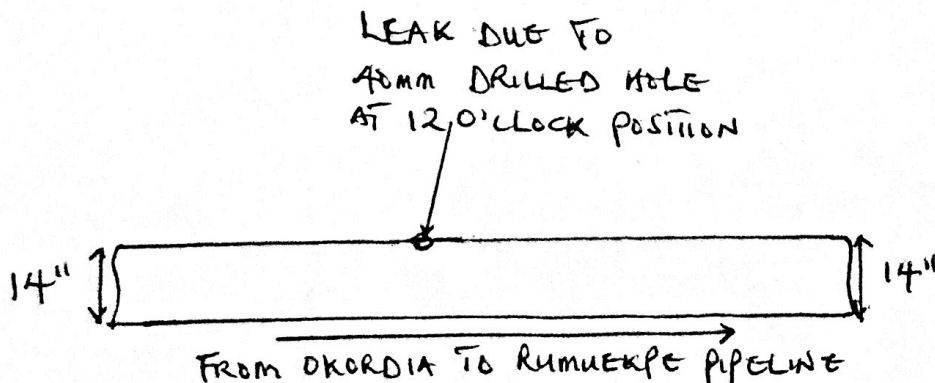
E. GRAPHIC DESCRIPTION OF LEAK POINT (while detailed description of the leak point should be contained in the leak report, overview sketch of the site should be added as appendix 1) A SECTION OF 14" OKORDIA - RUMUEKPE PIPELINE AT IHUOND SHOWING A 40mm DRILLED HOLE AT 12 O'CLOCK POSITION DONE BY UNKNOWN PERSONS.
