# JOINT INVESTIGATION REPORT

INCIDENT NO: 3050342 JIV report S/N: 0001050

1. Fountain Incident Number: 3050342 2. Type of incident\* OIL SPILL  
3. Name of Location 18" ASSA - RUMUKEPE PIPELINE  
4. Name of nearest community AWARRA 5. State: IMO 6. LGA OHAJI EGBEMA  
7. Production Facility/Installation CRUDE OIL PIPELINE  
8. Asset Owner/Hub THE SHELL PETROLEUM DEVELOPMENT COMPANY OF NIGERIA LIMITED / PIPELINE

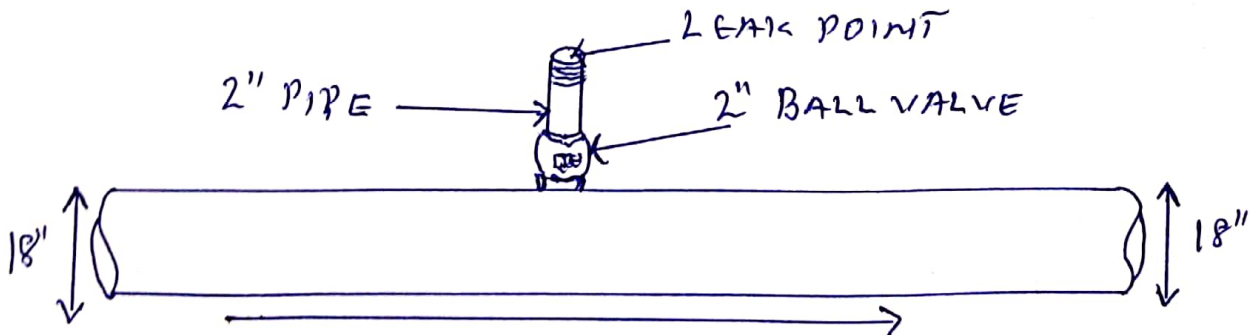
SECTION OF 18" ASSA - RUMUEKPE PIPELINE AT AWARRA SHOWING CRUDE OIL THEFT POINT INSTALLED AT 12 O'CLOCK POSITION BY UNKNOWN PERSONS.

FROM ASSA TO RUMUEKPE
