JOINT INVESTIGATION REPORT

INCIDENT NO: 3035385 JIV report S/N: 0001037

1. Fountain Incident Number: 3035385 2. Type of incident*: OIL SPILL
3. Name of Location: 20" KOLO CREEK- RUMUEKPE TRUNKLINE
4. Name of nearest community: OKOMA 5. State: RIVERS 6. LGA: AHOABA-EAST
7. Production Facility/Installation: OIL PIPELINE
8. Asset Owner/Hub: THE SHELL PETROLEUM DEVELOPMENT COMPANY (EASTERN HUB)

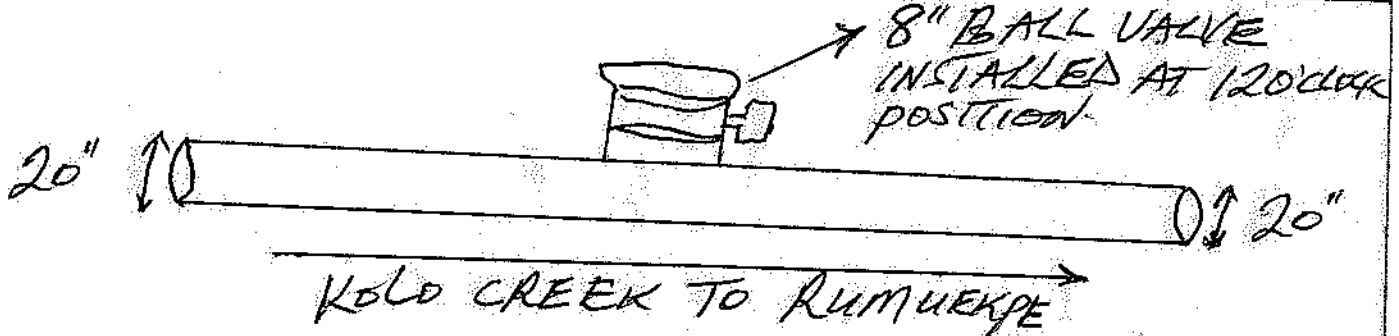
E. GRAPHIC DESCRIPTION OF LEAK POINT (while detailed description of the leak point should be contained in the leak report, overview sketch of the site should be added as appendix 1)

A SECTION OF 20" K6LO-CREEK-RUMUEKPE TRUNKLINE AT OKENNA SHOWING AN 8" BALL VALVE INSTALLED AT 12 O'CLOCK POSITION BY UNKNOWN PERSONS

REPAIR BY BLINDFLANGING
