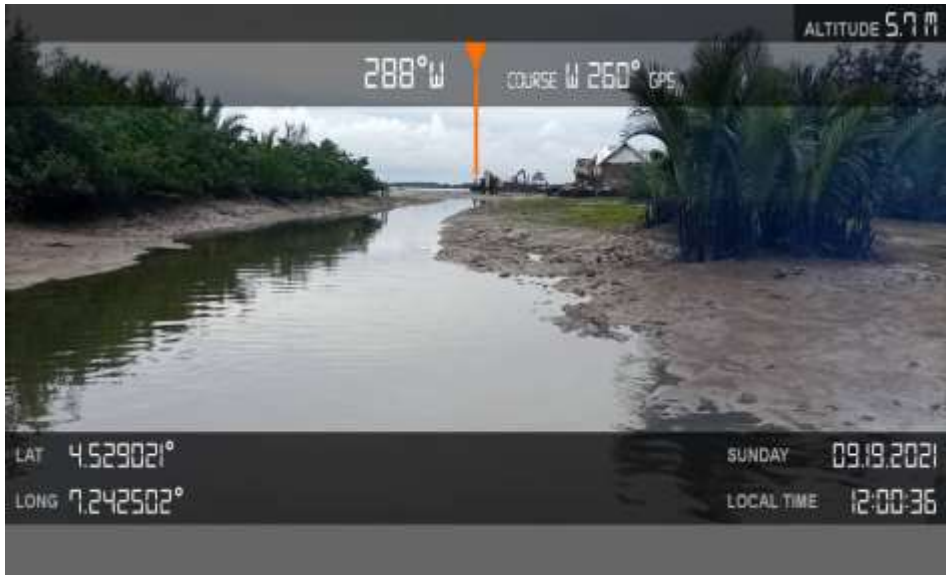
Overview: Part of spill impact on 28" Trans Niger Pipeline at Agba-Okwan Asarama .
 Picture was taken during Joint Investigation of 19th September 2021.

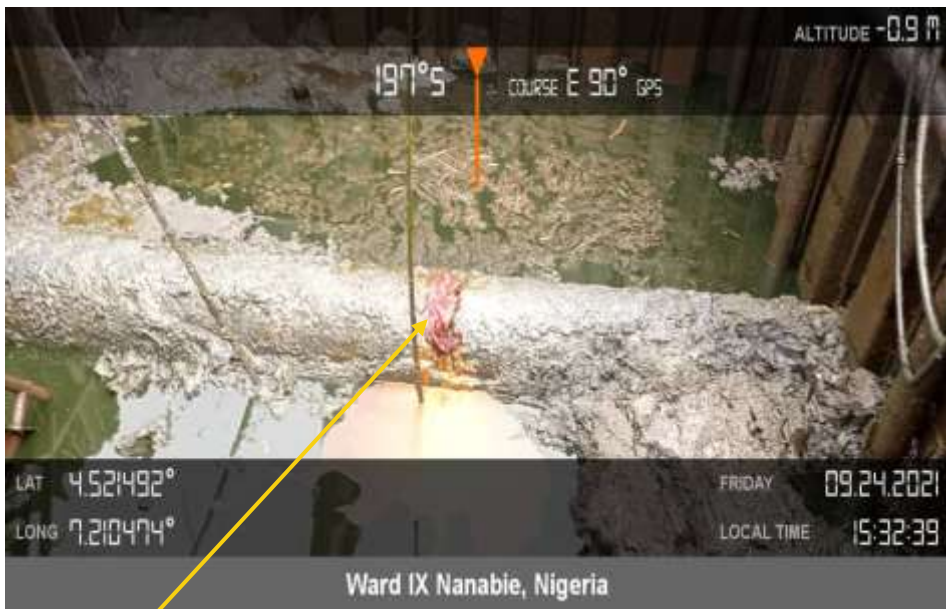
Close-up: 2-3mm pin hole at 11 o'clock position on 28" Trans Niger Pipeline at Agba-Okwan Asarama .Picture was taken during Joint Investigation of 24th September 2021.
