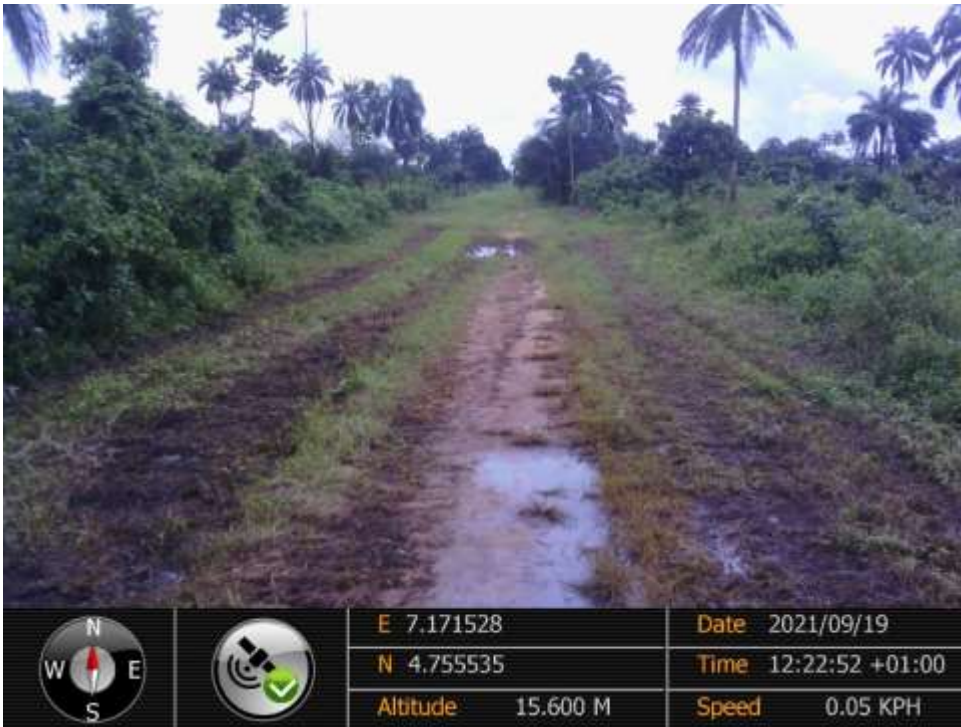
Overview: Part of spill impact on 28" Nkpoku Bomu Pipeline at Eteo.  
 Picture was taken during Joint Investigation of 19<sup>th</sup> September 2021.

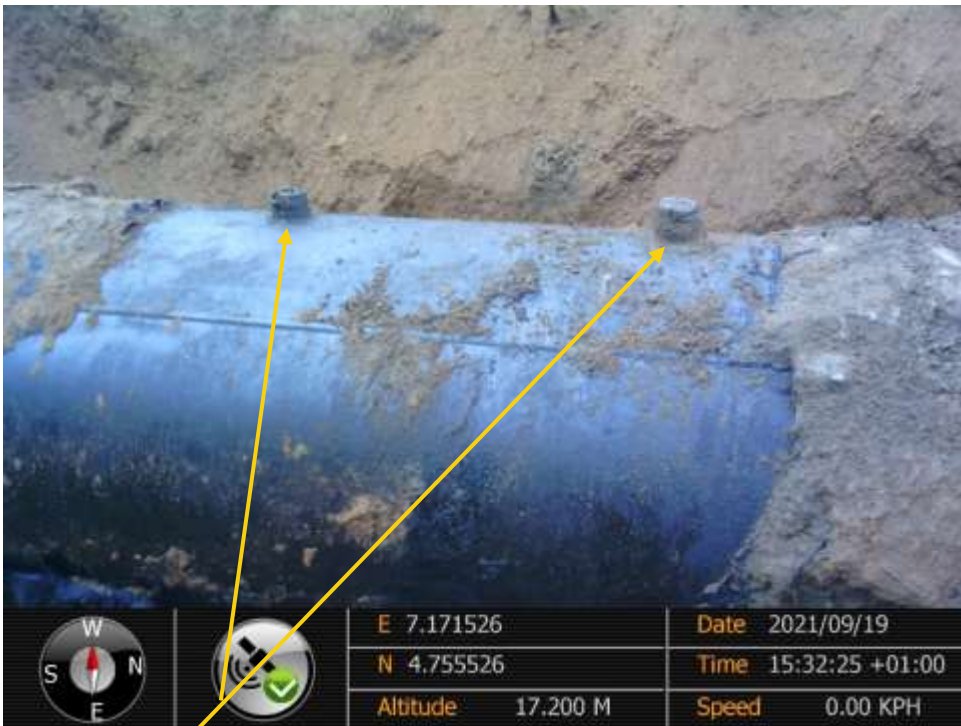
Close-up: 2nos of 2inch nipple installed at 12 o'clock position on 28" Nkpoku Bomu Pipeline at Eteo.  
 Picture was taken during Joint Investigation of 19<sup>th</sup> September 2021.
