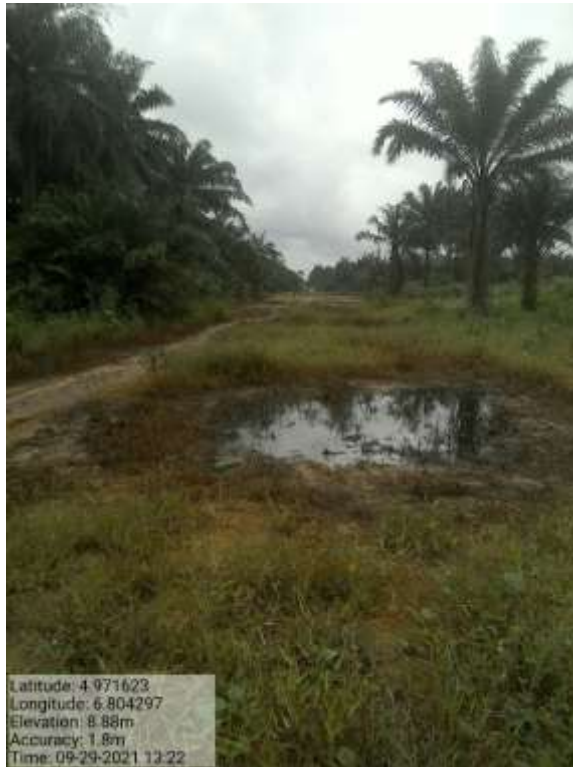
Overview: Part of spill impact on 4" Obele Ibaa Delivery line at Ibaa.
Picture was taken during Joint Investigation of 29th September 2021.

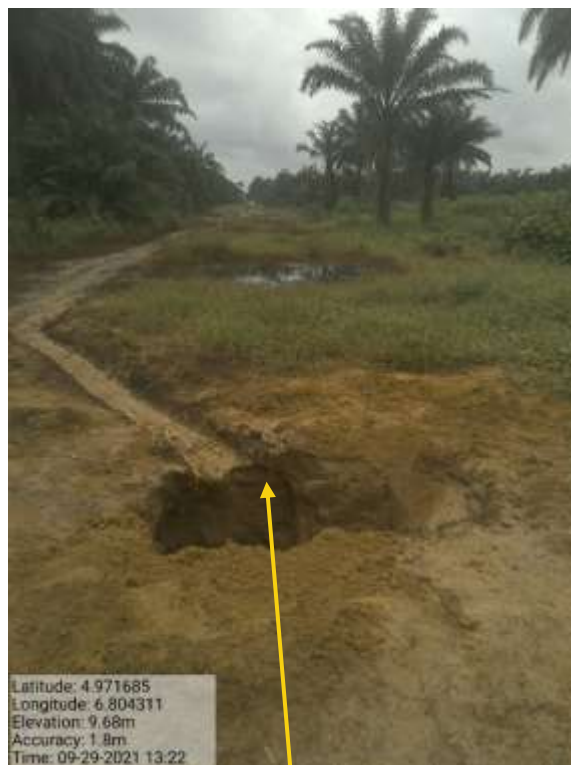
Overview (Excavated spill point) :
Part of spill impact on 4" Obele Ibaa Delivery line at Ibaa.
Picture was taken during Joint Investigation of 29th September 2021.

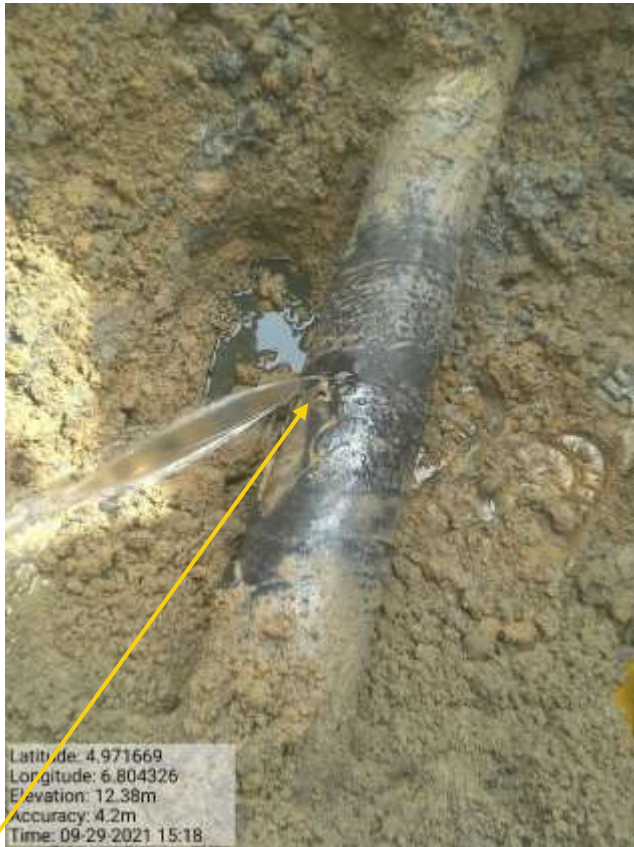
Close-up: Hacksaw cut at 9-11 o'clock position on 4" Obele Ibaa Delivery line at Ibaa. Picture was taken during Joint Investigation of 29th September 2021.
