JOINT INVESTIGATION REPORT

INCIDENT NO: 3037752 JIV report S/N: 0001040

1. Fountain Incident Number: 2021-3037752 2. Type of incident: OIL SPILL/FIRE
3. Name of Location: 20" KOLOCREEK - RUMUEKRE PIPELINE (OLD LINE)
4. Name of nearest community: OKOMA 5. State: RIVERS 6 LGA: AHIADA-EAST
7. Production Facility Installation: OIL PIPELINE
8. Asset Owner Hub: THE SHELL PETROLEUM DEVELOPMENT COMPANY
OF NIGERIA LIMITED (SPDC) / PIPELINE

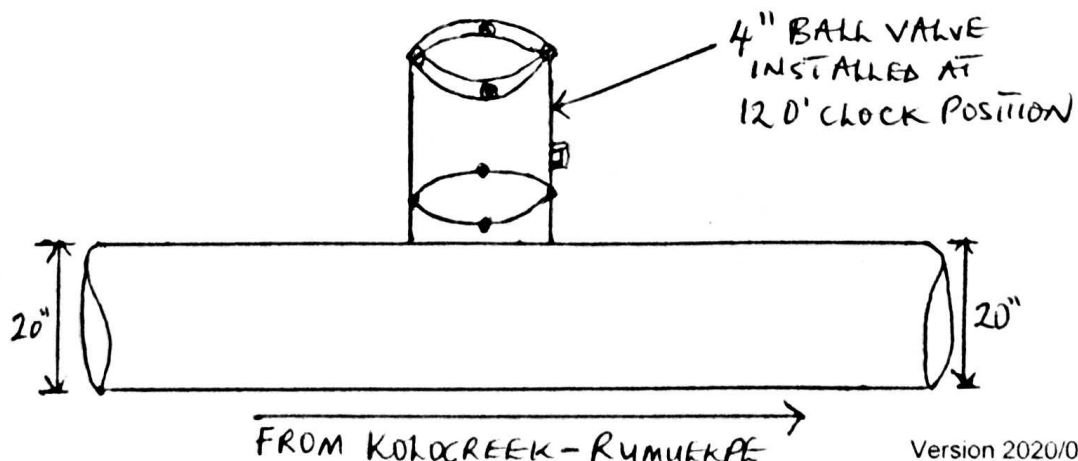
E. GRAPHIC DESCRIPTION OF LEAK POINT (while detailed description of the leak point should be contained in the leak report, overview sketch of the site should be added as appendix 1) A SECTION OF 20" KOLOCREEK RUMUEKPE PIPELINE AT OKOMA SHOWING A 4" BALL VALVE INSTALLED AT 12 O'CLOCK POSITION BY UNKNOWN PERSONS.

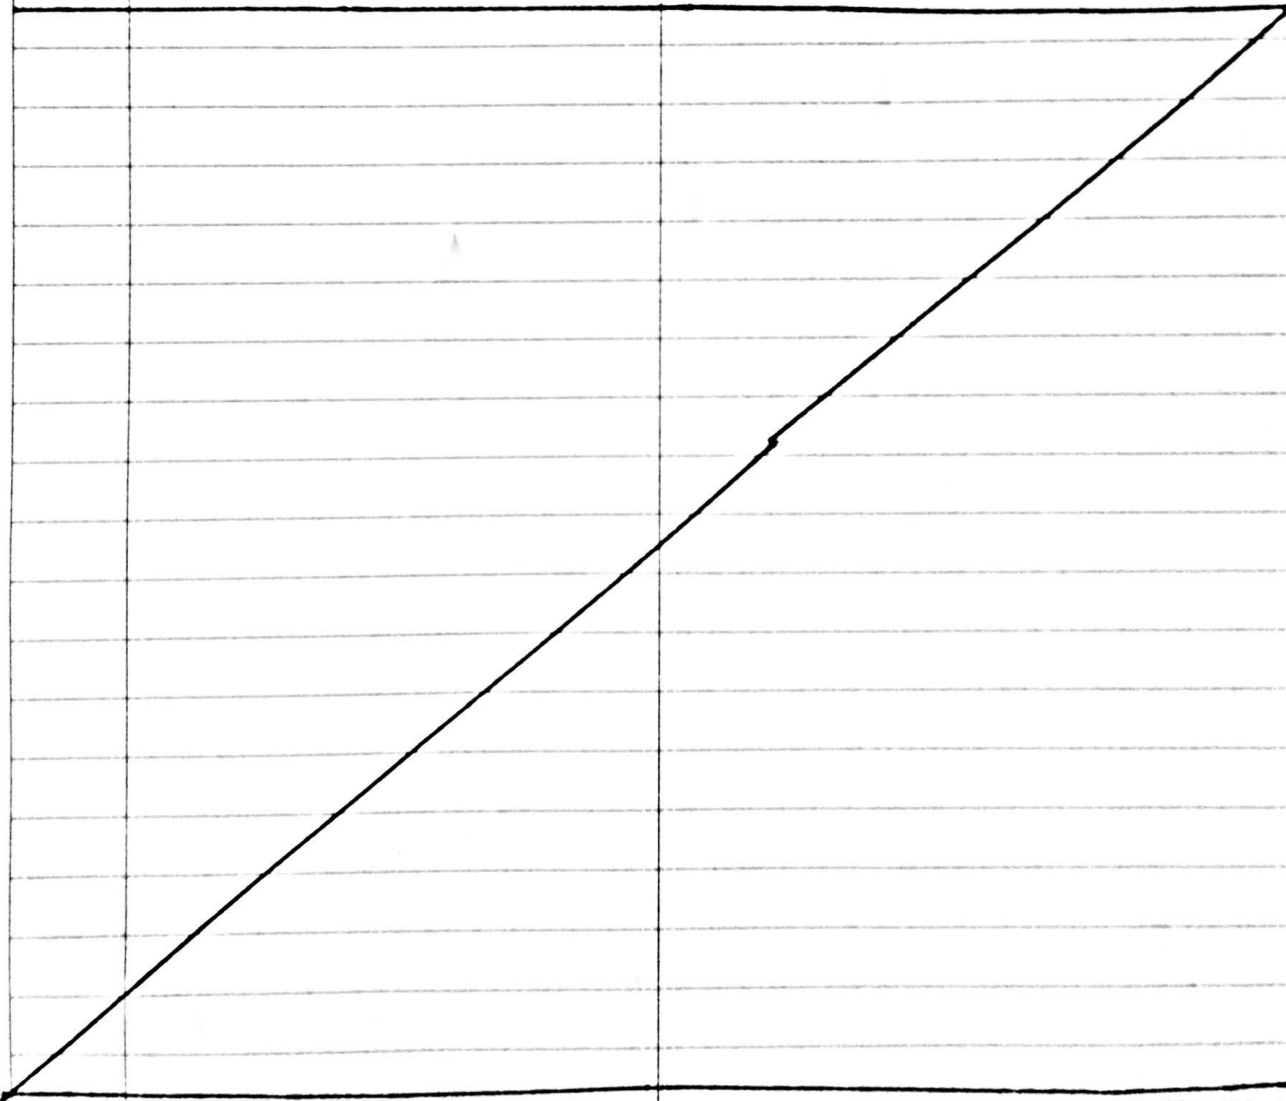
F: TABLE SHOWING SOME OF COORDINATES TAKEN DURING JIV FOR AREA CALCULATION

S/N	Northing	LATITUDE	Easting	LONGITUDE
		4.972123		6.650814
		4.97215		6.650715
		4.971908		6.650881
		4.971834		6.650813
