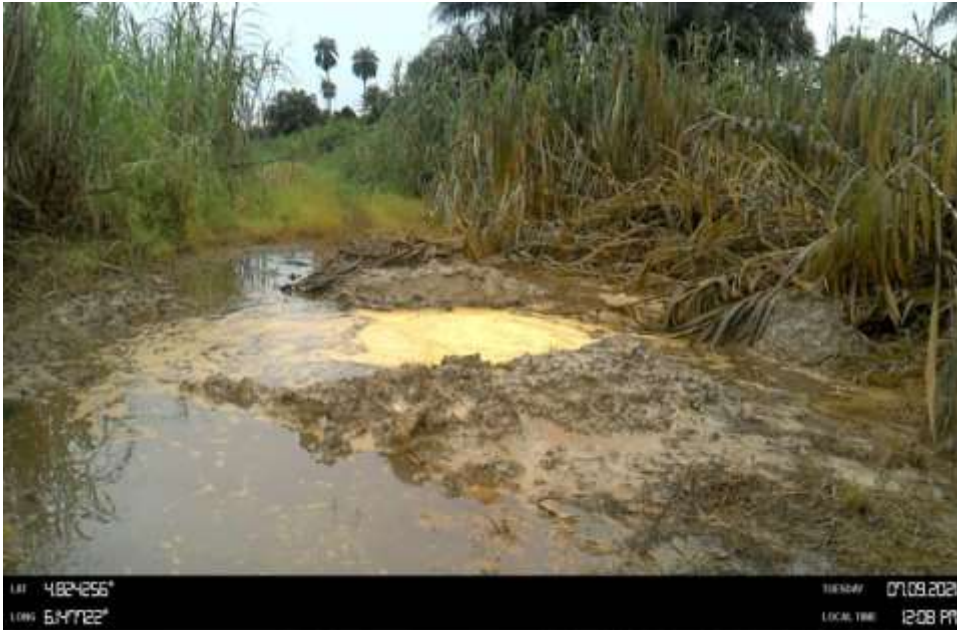
Overview: Part of spill impact on 16" Nun River Kolocreek Pipeline at Aguobiri. Picture was taken during Joint Investigation of 7th September 2021.

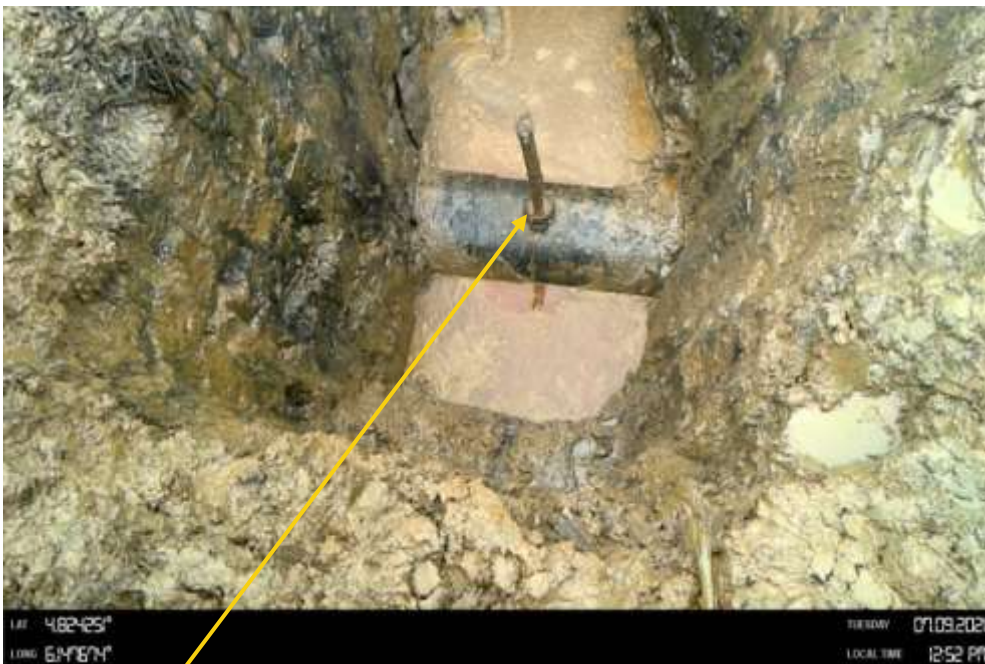
Close-up: Plugged 3inch nipple installed at 12 o'clock position on 16" Nun River Kolocreek Pipeline at Aguobiri. Picture was taken during Joint Investigation of 7th September 2021.
