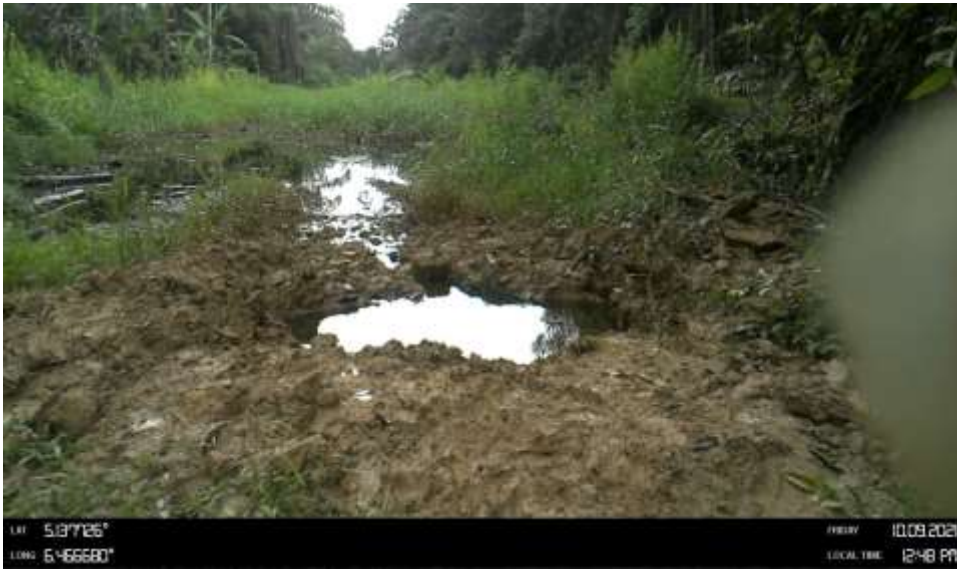
Overview: Part of spill impact on 14" Okordia Rumuekpe Pipeline at Ikarama. Picture was taken during Joint Investigation of 10<sup>th</sup> September 2021.

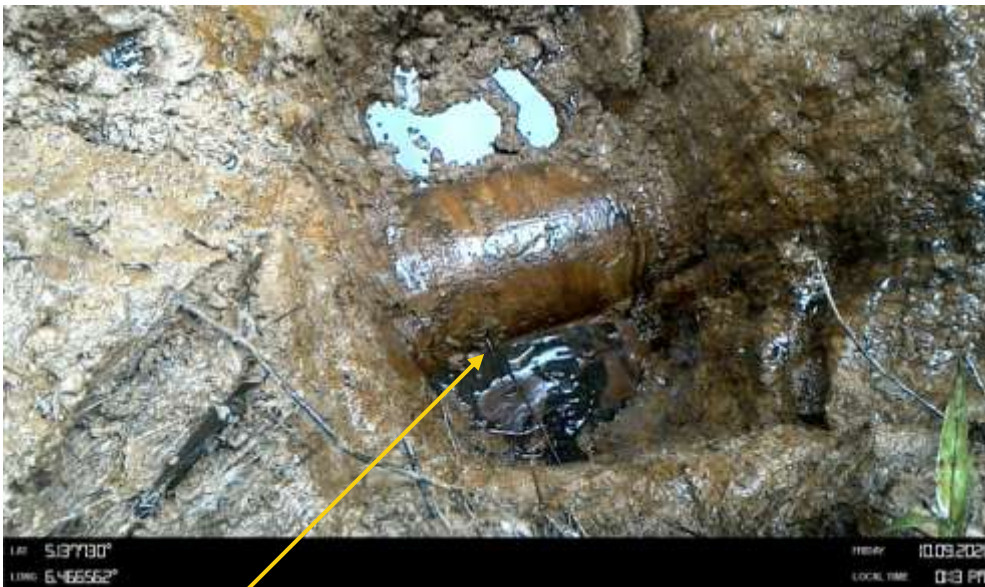
Close-up: 70mm Hacksaw cut at 9 o'clock position on 14" Okordia Rumuekpe Pipeline at Ikarama. Picture was taken during Joint Investigation of 10<sup>th</sup> September 2021.
