JOINT INVESTIGATION REPORT

INCIDENT NO: 302 6163 JIV report S/N: 0000924

1. Fountian Incident Number: 302 6163 2. Type of incident* OIL SPILL
3. Name of Location 14" OKORDIA - KUMUEKPE PIPELINE
4. Name of nearest community IKARAMA 5. State: BAYELSA 6. LGA TENAGOA
7. Production Facility/Installation OIL PIPELINE
8. Asset Owner/Hub THE SHELL PETROLEUM DEVELOPMENT COMPANY OF NIGERIA LIMITED (SPDC)/PIPELINE

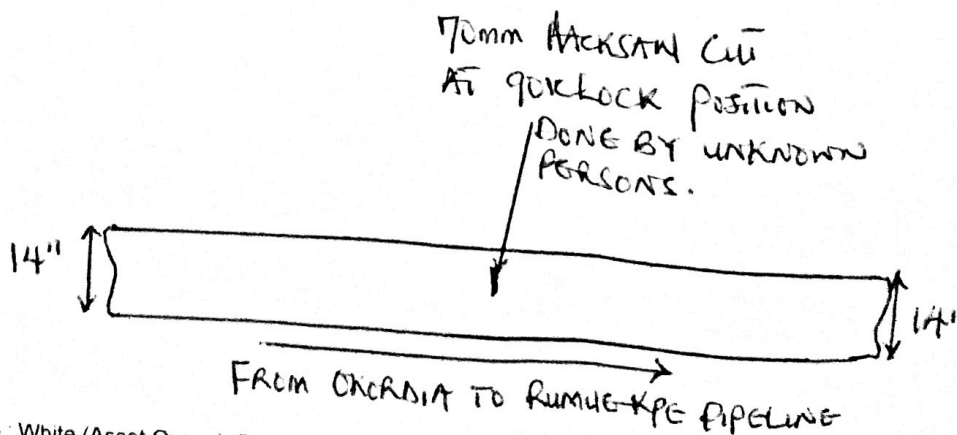
RUMUEKPE PIPELINE AT IKARAMA SHOWING A 70mm HACKSAW CUT AT 9 O'CLOCK POSITION DONE BY UNKNOWN PERSONS.
