JOINT INVESTIGATION REPORT

INCIDENT NO: 1688432 JIV report S/N: Nº 0000160

1. Spill incident Number: 1688432 2. Type of incident* OIL SPILL
3. Name of Location 12th IKO RIVER 2 - OGALE TRANS NIGER PIPELINE
4. Name of nearest community OWAZA 5. State: ABIA 6. LGA UKWA WEST
7. Type of Production facility/Installation OIL PIPELINE
8. Asset owner/District PIPELINE EAST / THE SHELL PETROLEUM DEVELOPMENT COMPANY OF NIGERIA LIMITED

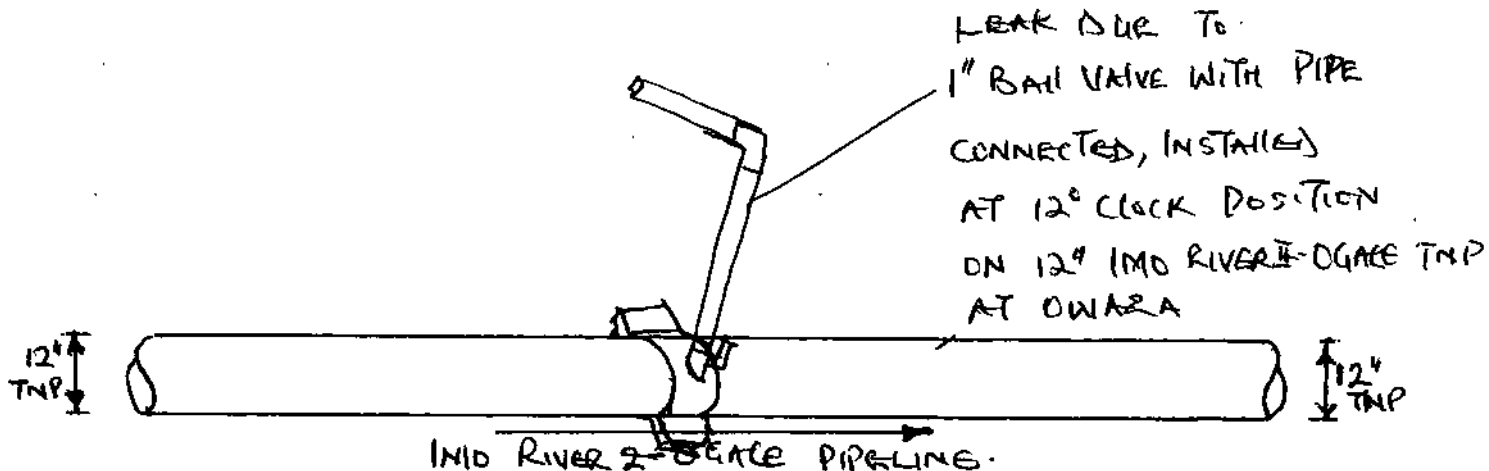
Additional observations around the spill point: TEAM (JIV) OBSERVED THE USE OF LOCAL CLAMPS TO INSTALL THE THEFT POINT ON THE PIPELINE.

| <input checked="" type="checkbox"/> Crude oil theft (illegal bunkering) point, | <input type="checkbox"/> Saver-pit over flow | <input type="checkbox"/> Third party tampering with Clamp |

SECTIONAL VIEW OF 12" IMD RIVER-OGALE TRANS NIGER PIPELINE AT OWAZA
SHOWING: - CRUDE OIL ILLEGAL THEFT POINT.
