Overview: Part of spill impact on 24" Alakiri-Bonny pipeline right of way at Ilomaturu. Picture was taken during Joint Investigation of 29th August 2013.

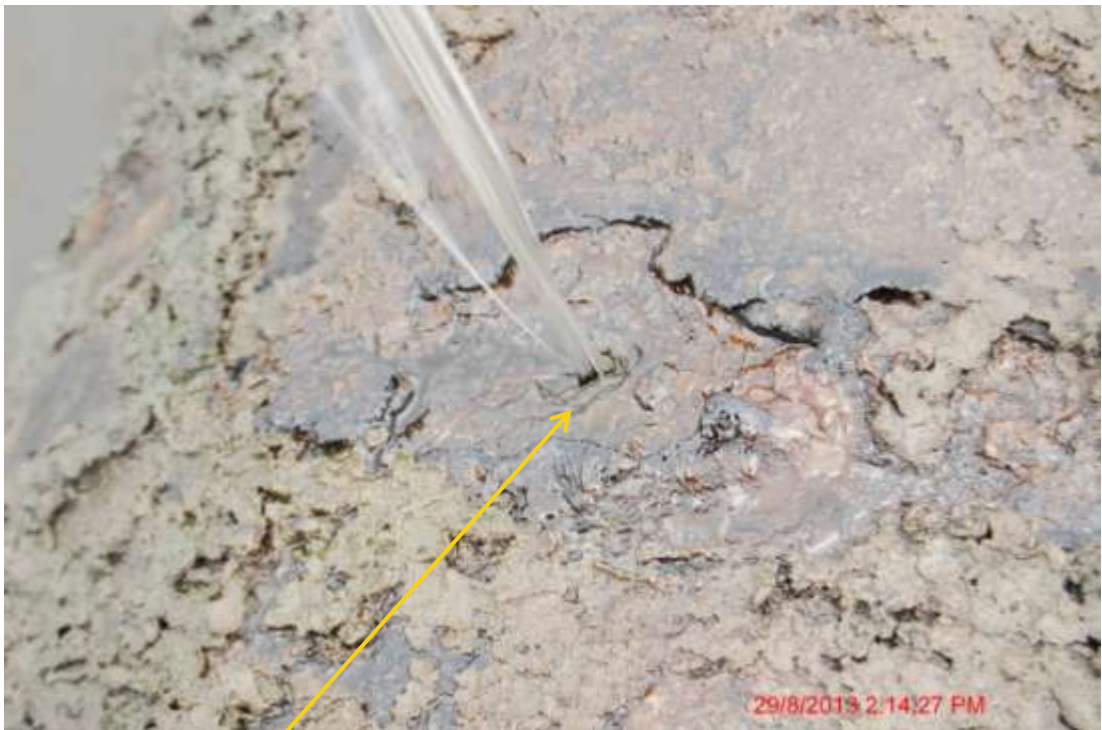
Close up: Hole due to corrosion on 24" Alakiri-Bonny pipeline at Ilomaturu. Picture was taken during Joint Investigation of 29th August 2013.
