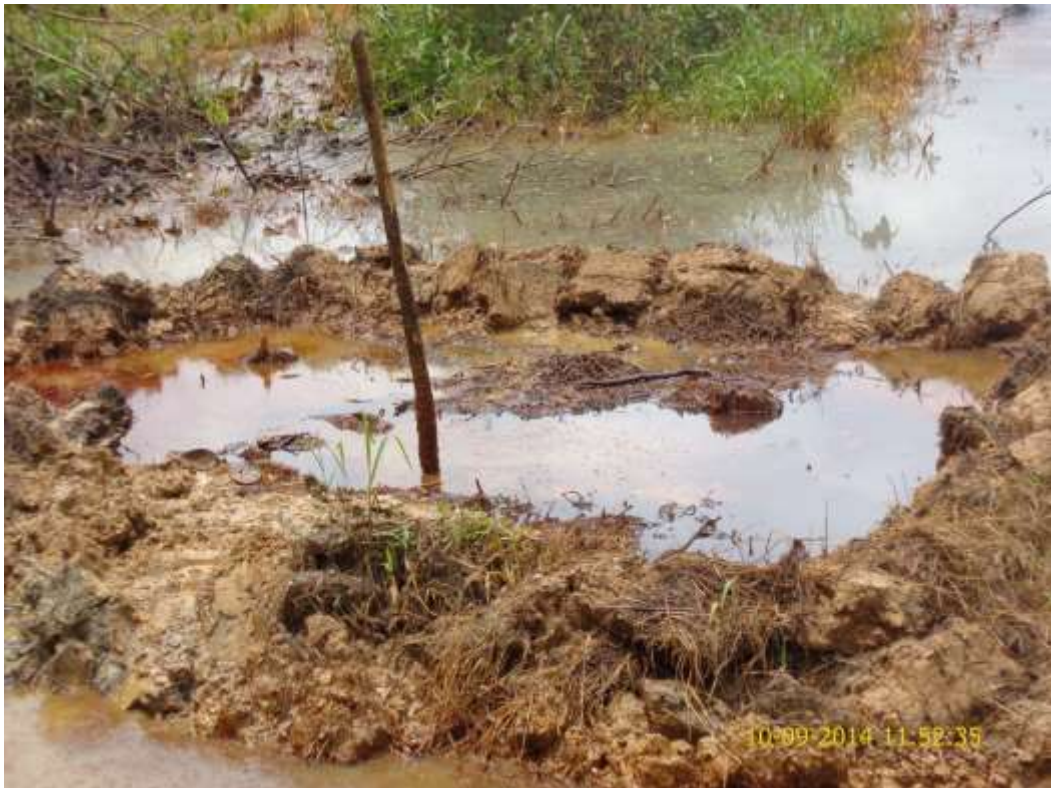
Overview: Part of spill impact on 10" Diebu Creek – Nun River Pipeline Right of Way at Ekowe. Picture was taken during Joint Investigation of 10th September 2014.

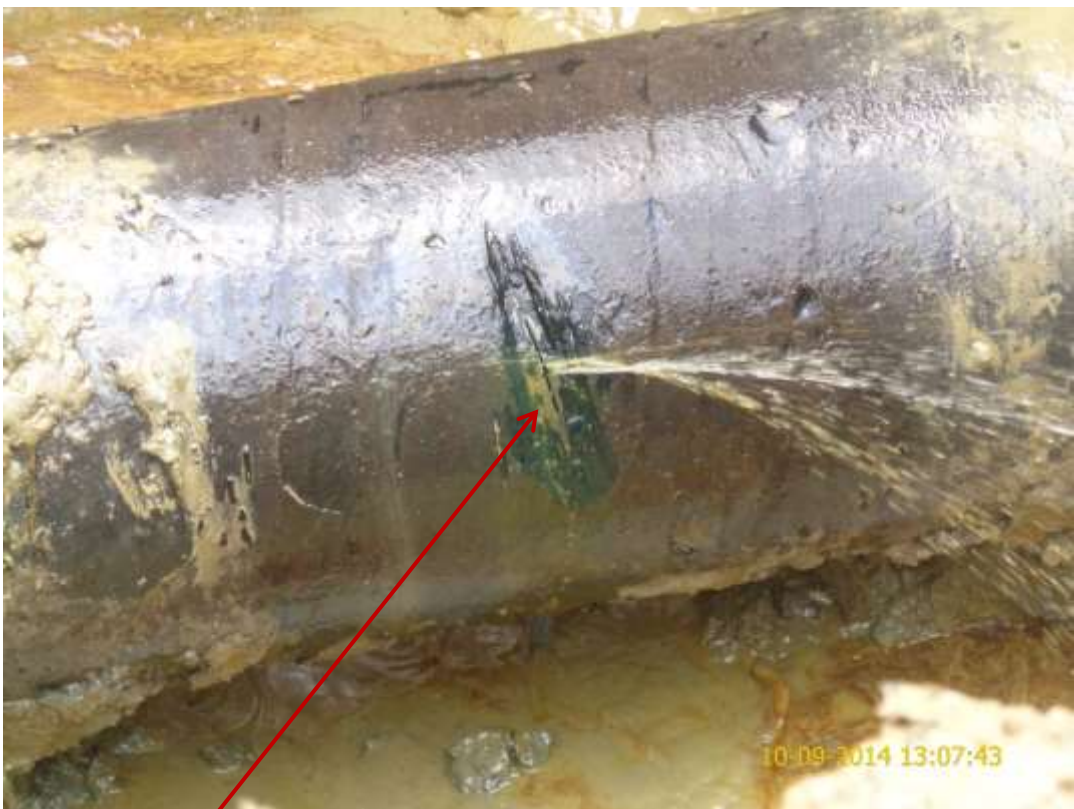
Close-up: Hacksaw cut on 10" Diebu Creek – Nun River Pipeline Right of Way at Ekowe. Picture was taken during Joint Investigation of 10th September 2014.
