# JOINT INVESTIGATION REPORT

INCIDENT NO: 1760992 JIV report S/N: Nº 0000304

1. Spill incident Number: 1760992 2. Type of incident\* OIL SPILL  
3. Name of Location 2" YOKRI WELL-127T GAS LIFT LINE  
4. Name of nearest community YOKRI 5. State: DELTA 6. LGA BURUTU  
7. Type of Production facility/Installation GAS LINE  
8. Asset owner/District THE SHELL PETROLEUM DEVELOPMENT COMPANY OF NIGERIA LIMITED/SWAMP WEST

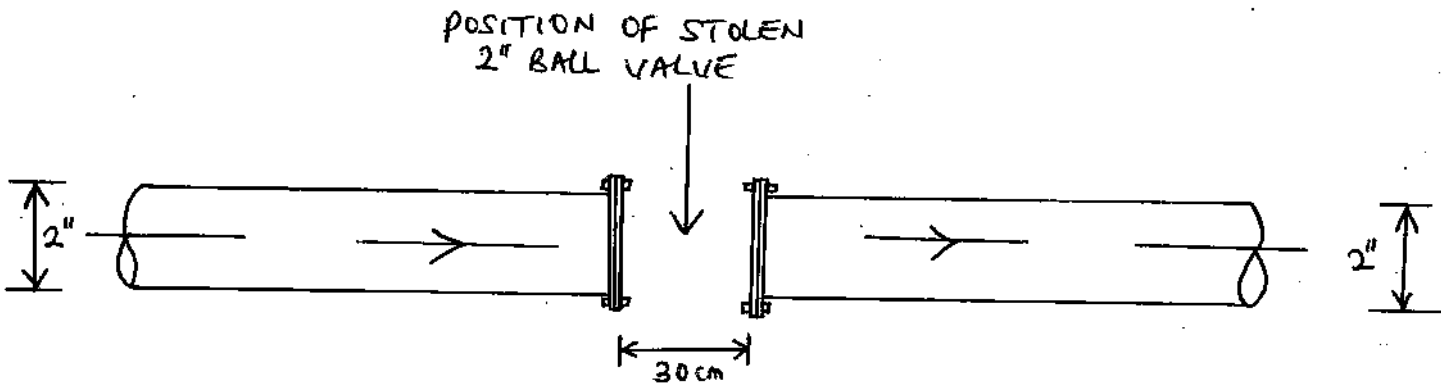
Additional observations around the spill point: ON ASSESSMENT, THE JOINT INVESTIGATION TEAM OBSERVED THAT THE 2" BALL VALVE ON YOKRI WELL-127T GAS LIFT LINE WAS REMOVED BY UNKNOWN PERSONS. THE TWO OPEN ENDS OF THE GAS LINE WERE OBSERVED TO HAVE BEEN BLIND FLANGED PRIOR TO JIV.

SECTION OF 2" YOKRI WELL - 12 FT GAS LIFT LINE AT YOKRI  
SHOWING POSITION OF STOLEN 2" BALL VALVE
