# JOINT INVESTIGATION REPORT

INCIDENT NO: 1762022 JIV report S/N:

1. Spill incident Number: 1762022 2. Type of incident\* OIL SPILL  
3. Name of Location 28" BONNY - BONNY PIPELINE  
4. Name of nearest community OTOKOLOMABIE 5. State: RIVERS 6. LGA BONNY  
7. Type of Production facility/Installation OIL PIPELINE  
8. Asset owner/District SPDC / PIPELINE

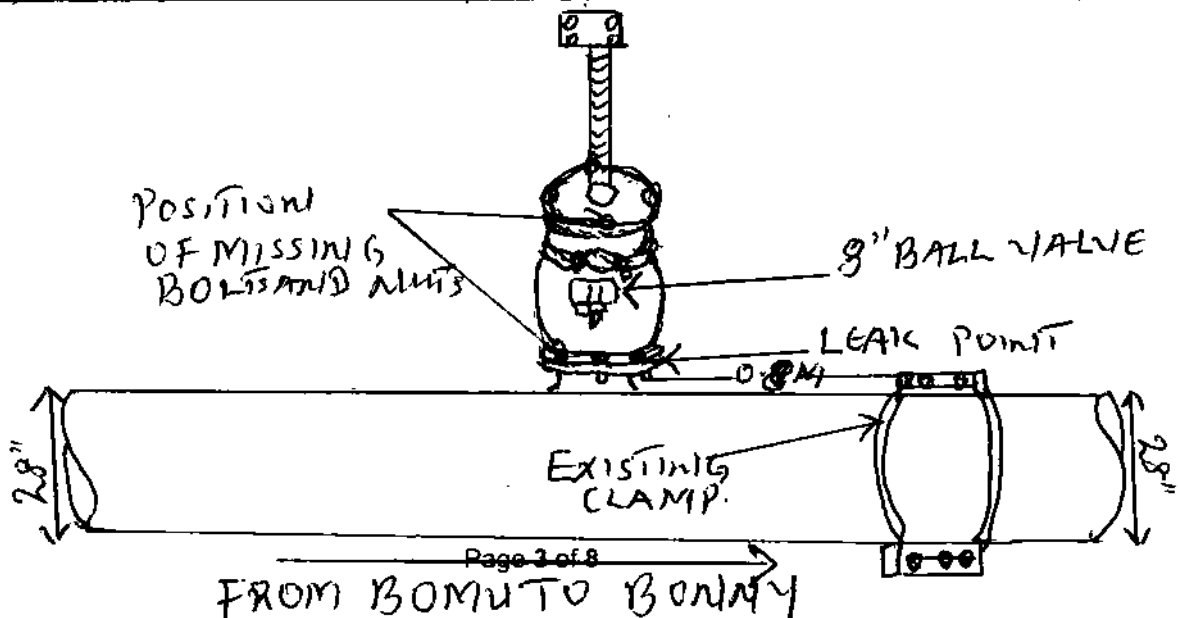
| <input checked="" type="checkbox"/> Failed Weld-on illegal hot tap valve | <input type="checkbox"/> Failed Clamp, | <input type="checkbox"/> Missing Pipeline/Flowline |
| <input checked="" type="checkbox"/> Crude oil theft (illegal bunkering) point, | <input type="checkbox"/> Saver-pit over flow | <input type="checkbox"/> Third party tampering with Clamp |

SECTION OF 28" BOMU - BONNY PIPELINE AT OTOKOLOMABIE (OLOMA) SHOWING CRUDE OIL THEFT POINT INSTALLED AT 12 O'CLOCK POSITION.

RECOVERY OF SPILLED OIL AND REPAIR ACTIVITIES ARE ONGOING.
