# JOINT INVESTIGATION REPORT

INCIDENT NO: 2019516 JIV report S/N: 1015

- 1. Spill incident Number: 2019516      2. Type of incident\* OIL SPILL
- 3. Name of Location 12" ADIBAWA - OKORDIA PIPELINE
- 4. Name of nearest community IKARAMA 5. State: BAYELSA 6. LGA YENAGOA
- 7. Type of Production facility/Installation OIL PIPELINE
- 8. Asset owner/District THE SHELL PETROLEUM DEVELOPMENT COMPANY OF NIGERIA LIMITED / PIPELINE

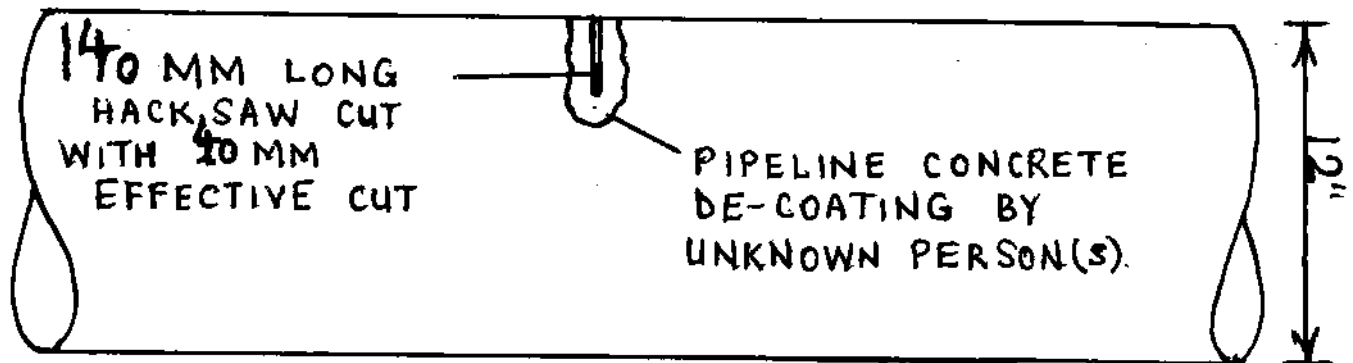
Additional observations around the spill point: **UPON EXCAVATION TO EXPOSE THE SPILL POINT, A SECTION OF THE PIPELINE CONCRETE COATING AROUND THE SPILL POINT WAS NOTICED TO HAVE BEEN REMOVED BY UNKNOWN PERSON(S).**

SECTION OF 12" ADIBAWA - OKORDIA PIPELINE AT IKARAMA SHOWING HACK SAW CUT (LEAK POINT) BETWEEN 11 AND 12 O' CLOCK POSITIONS.

← FROM ADIBAWA  
To OKORDIA
