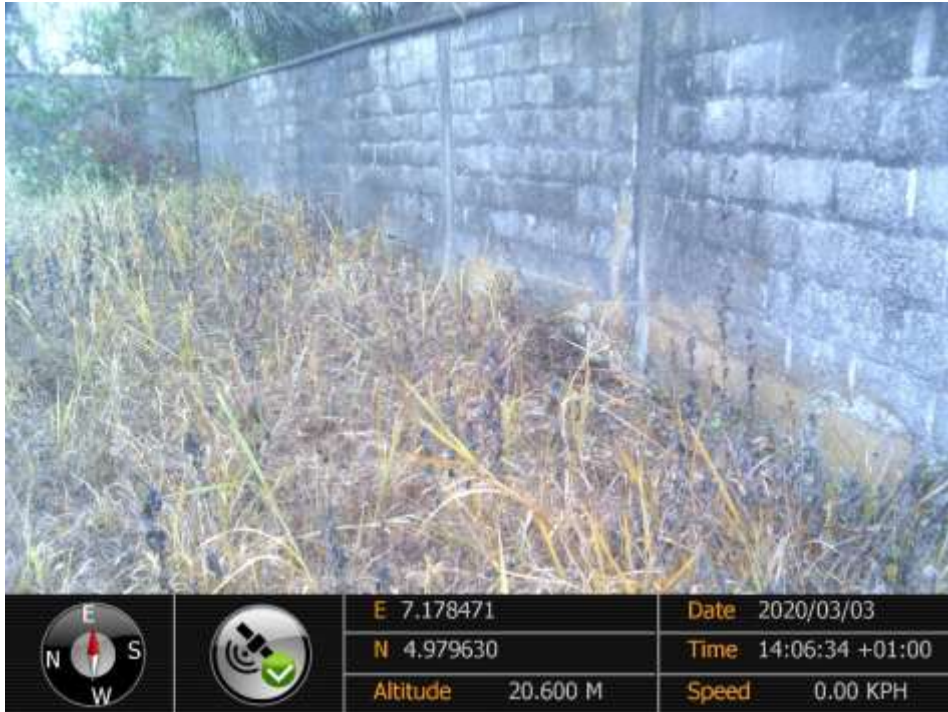
**Overview:** Part of spill impact on 4'' Imo River Well 43T Flowline at Igiriukwu. Picture was taken during Joint Investigation of 3<sup>rd</sup> March 2020.

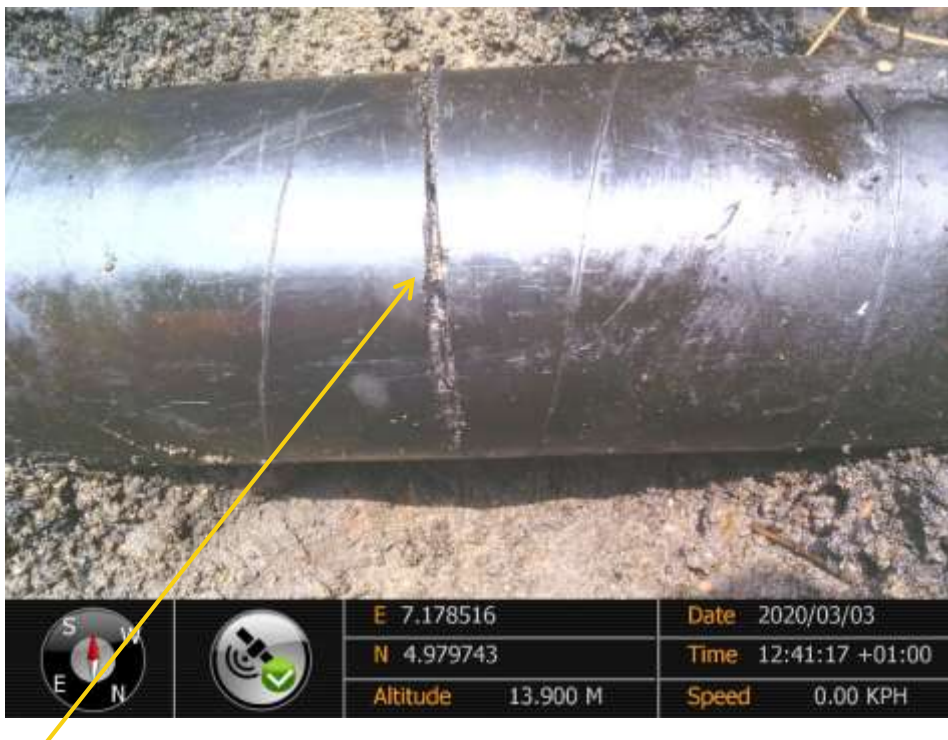
**Close-up:** Hacksaw cut from 9 -3 o'clock position on 4'' Imo River Well 43T Flowline at Igiriukwu. Picture was taken during Joint Investigation of 3<sup>rd</sup> March 2020.
