THE SHELL PETROLEUM DEVELOPMENT COMPANY OF NIGERIA LIMITED

JOINT INVESTIGATION REPORT FOR INCIDENT NO: 0178 766391

1. Spill incident Number: 766391 2. Type of incident* OIL SPILL
 3. Name of Location 36" NKPOKU - BOMU PIPELINE
 4. Name of nearest community ENEKA 5. State: RIVERS 6. LGA OBIO / AKPOR
 7. Type of Production facility/Installation PIPELINE 8. Asset owner/District NPE / PH I

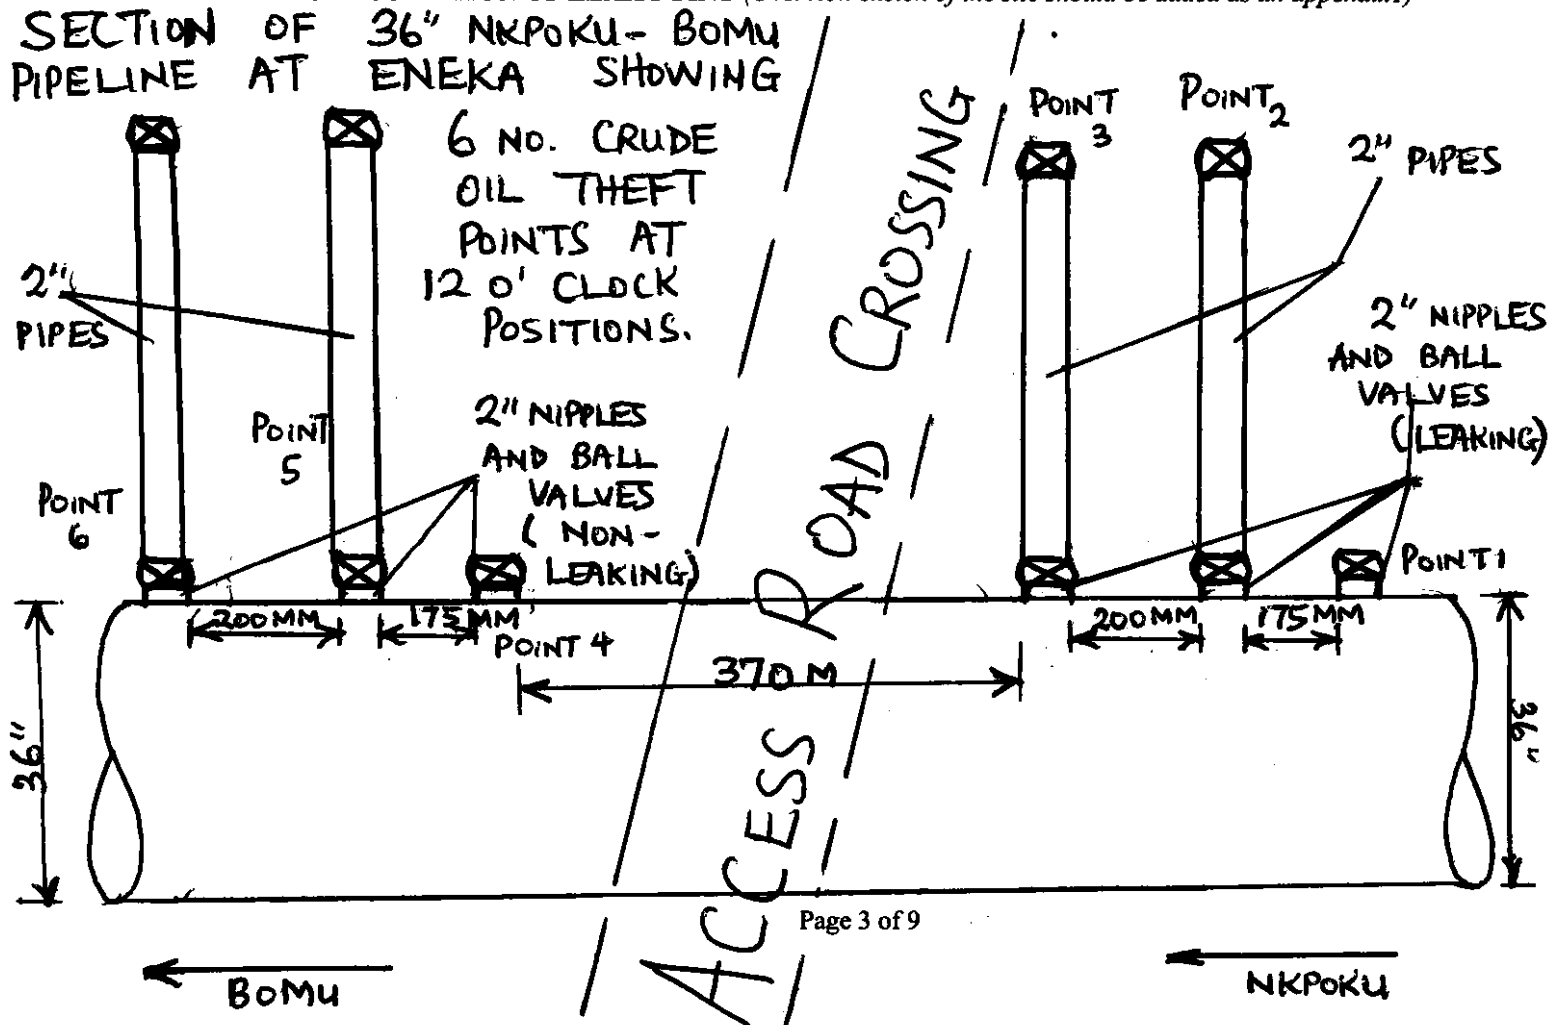
E. GRAPHIC DESCRIPTION OF LEAK POINT (Overview sketch of the site should be added as an appendix 1)

| <input checked="" type="checkbox"/> Failed Weld-on illegal hot tap valve, | | <input type="checkbox"/> Missing Pipeline/Flowline) |
| <input checked="" type="checkbox"/> Crude oil theft (illegal bunkering) point, | | <input type="checkbox"/> Third party tampering with Clamp |

Measuring unit		MUNNA MID BELT	
Northing: (m)		Easting: (m)	
POINTS 1, 2 AND 3	99220.86	510215.16	
POINTS 4, 5 AND 6	98986.79	510491.96
