THE SHELL PETROLEUM DEVELOPMENT COMPANY OF NIGERIA LIMITED

JOINT INVESTIGATION REPORT FOR INCIDENT NO: 0537 914544

1. Spill incident Number: 914544 2. Type of incident * OIL SPILL
 3. Name of Location 24" BOMU - BONNY PIPELINE
 4. Name of nearest community MOGHO 5. State: RIVER 6. LGA GOKANJA
 7. Type of Production facility/Installation OIL PIPELINE 8. Asset owner/ District NPE / PH1

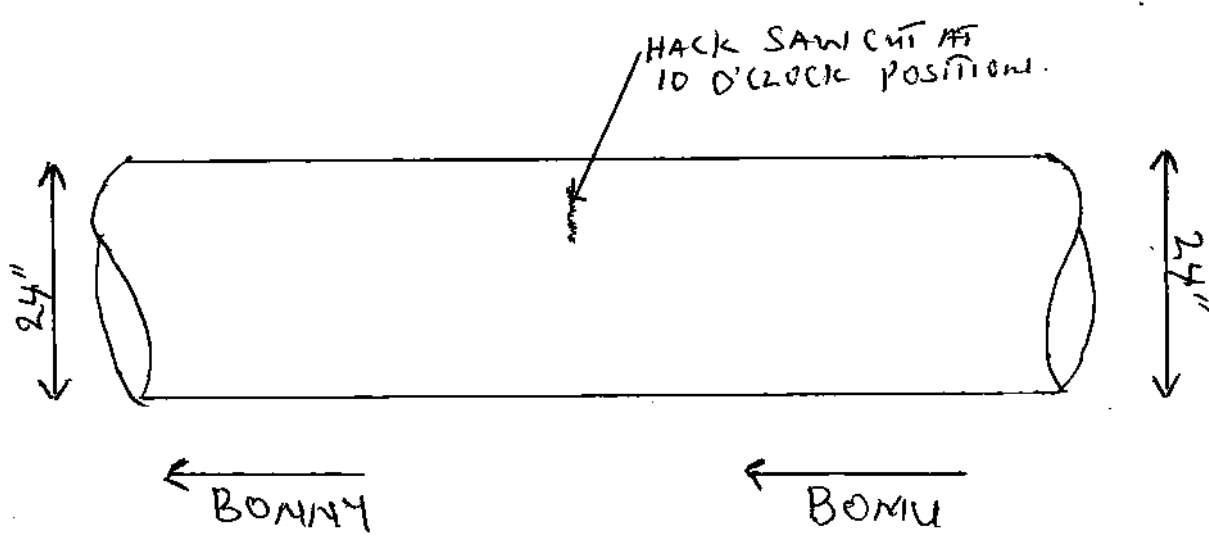
SECTION OF 24" BONNY - BONNY PIPELINE AT MUGHO
SHOWING POSITION OF HACK SAW CUT AT 10 O'CLOCK POSITION.
