**Overview:** Part of spill impact on 14" Okordia - Rumuekpe Pipeline Right of Way at Ikarama. Picture was taken during Joint Investigation of 30<sup>th</sup> July 2019.

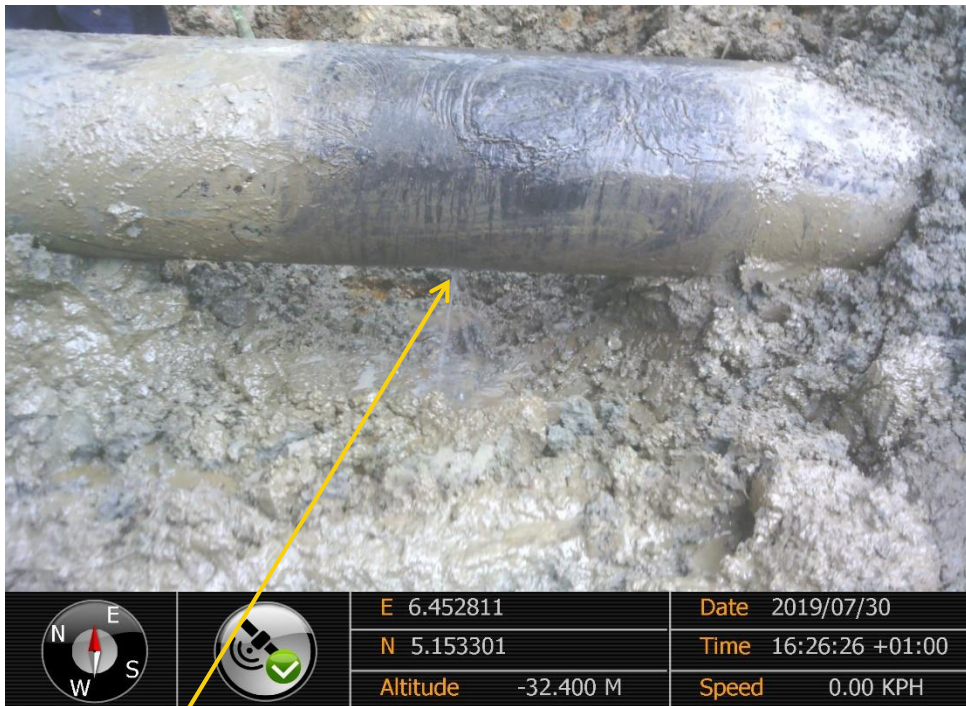
**Close-up:** Internal Corrosion on 14" Okordia - Rumuekpe Pipeline at Ikarama. Picture was taken during Joint Investigation of 30<sup>th</sup> July 2019

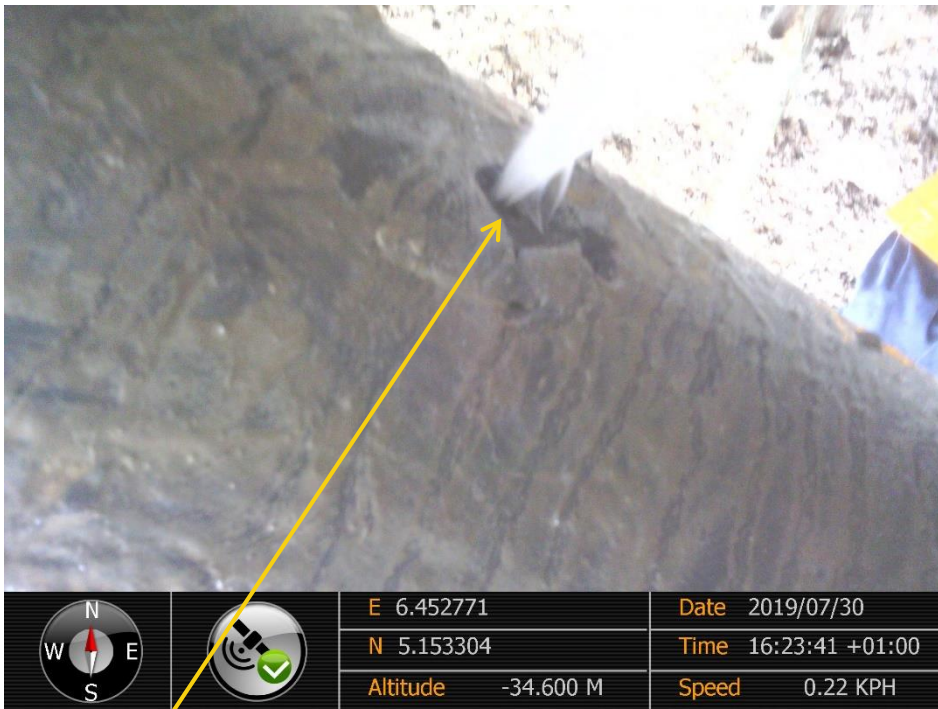
Close-up: Internal Corrosion on 14" Okordia - Rumuekpe Pipeline at Ikarama. Picture was taken during Joint Investigation of 30<sup>th</sup> July 2019
