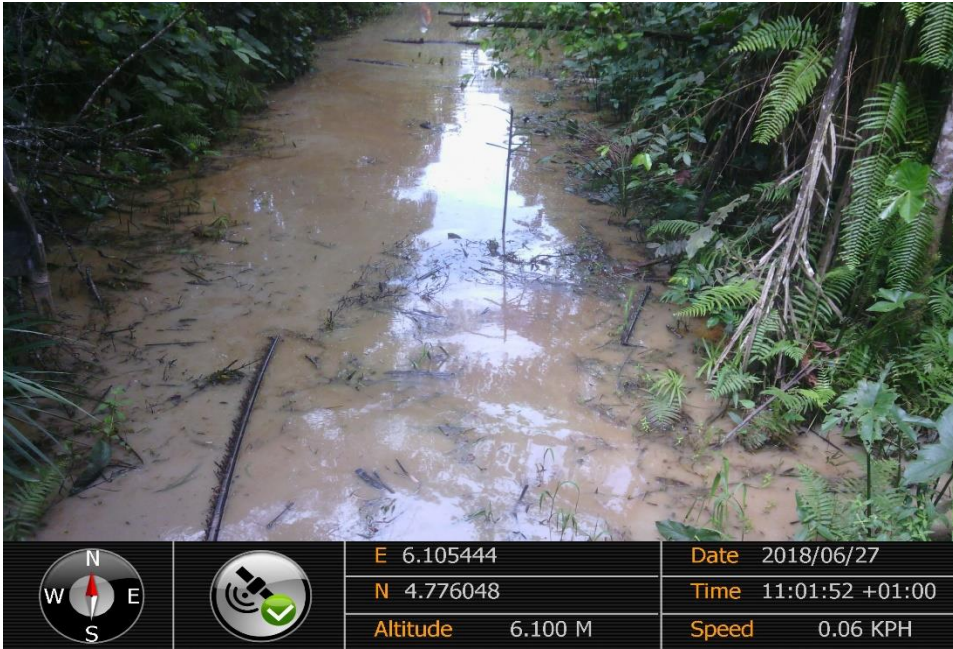
**Overview:** Part of spill impact on 10'' DiebuCreek– Nun River Pipeline Right of Way at Oporoma. Picture was taken during Joint Investigation of 27<sup>th</sup> June 2018.

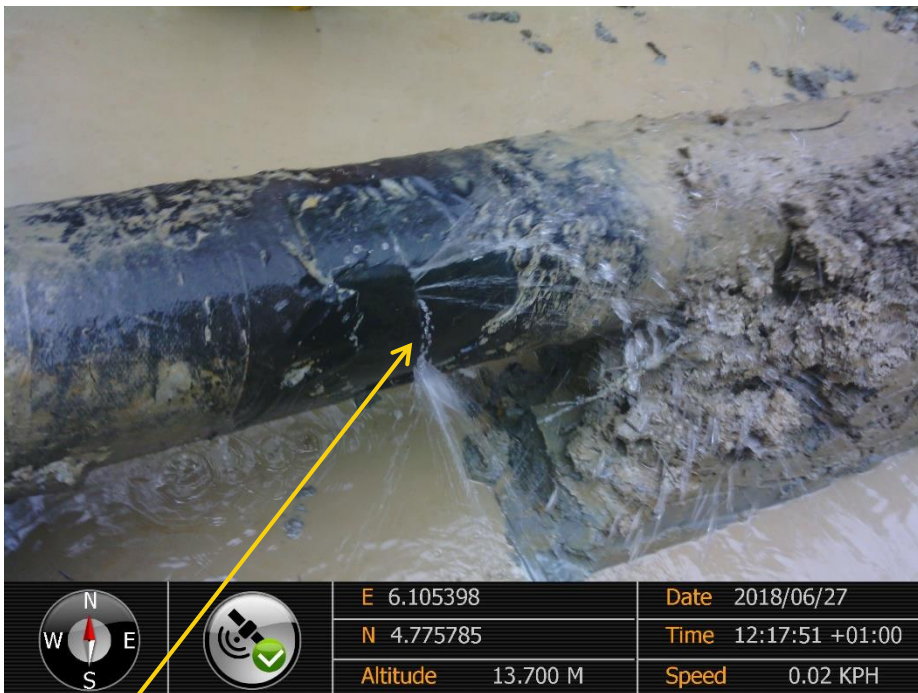
**Close-up:** Hacksaw Cut on 10'' DiebuCreek– Nun River Pipeline at Oporoma. . Picture was taken during Joint Investigation of 27<sup>th</sup> June 2018.
