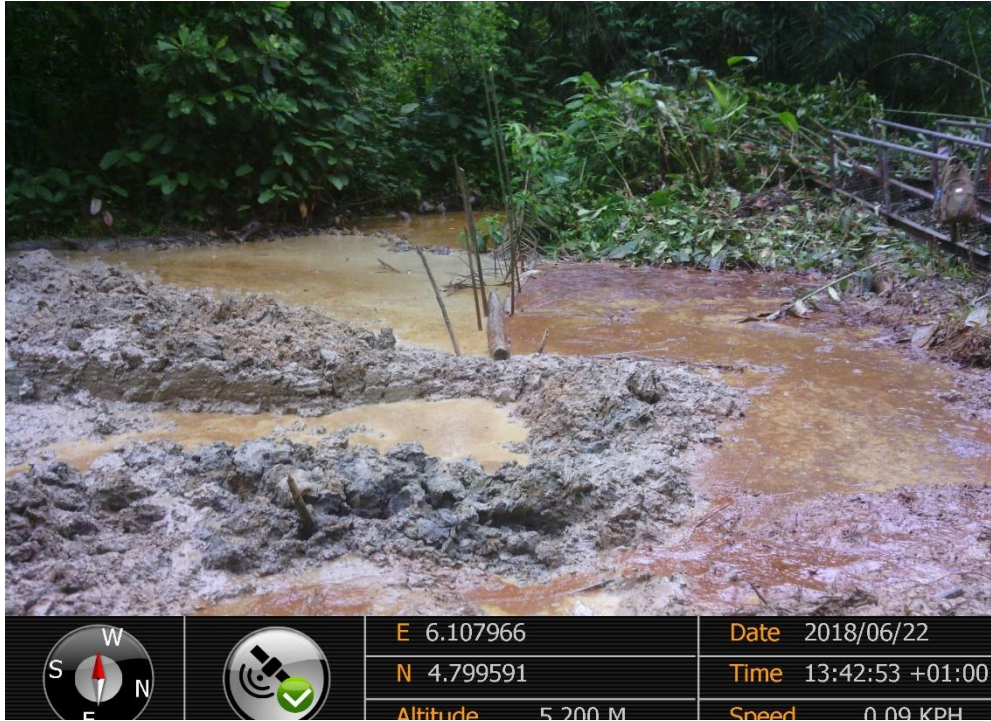
Overview: Part of spill impact on 10'' DiebuCreek– Nun River Pipeline Right of Way at Oporoma. Picture was taken during Joint Investigation of 22nd June 2018.

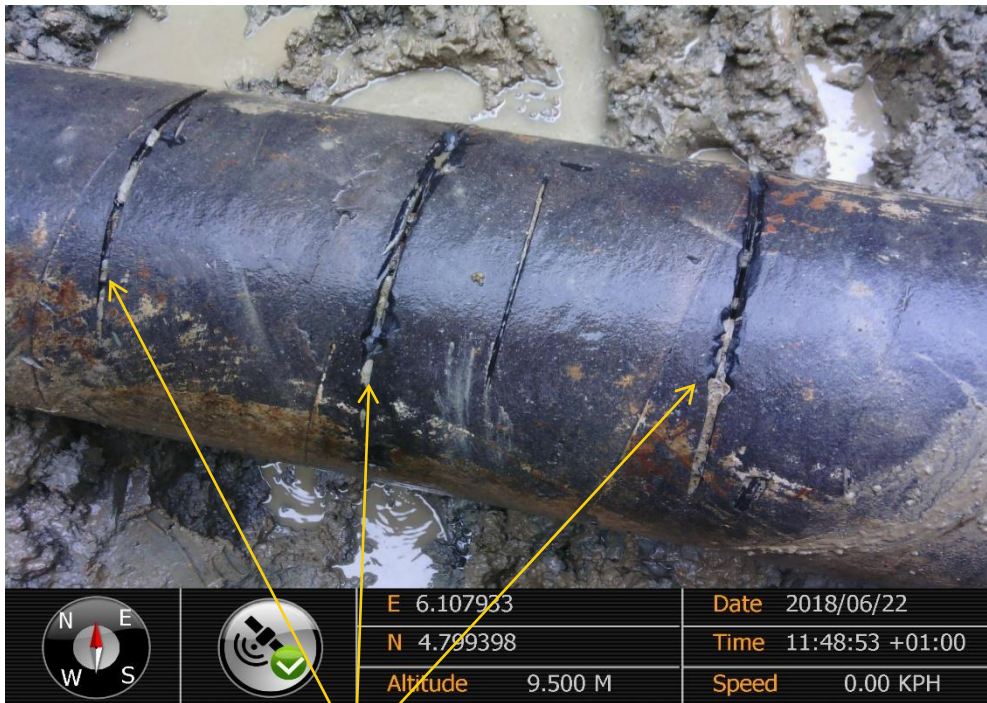
Close-up: Leaking multiple Hacksaw Cuts on 10'' DiebuCreek– Nun River Pipeline at Oporoma. Picture was taken during Joint Investigation of 22nd June 2018.
