Overview: Part of spill impact on 20" Kolocreek-Rumuekpe Pipeline Right of Way at Odau KM9. Picture was taken during Joint Investigation of 4th July 2018.

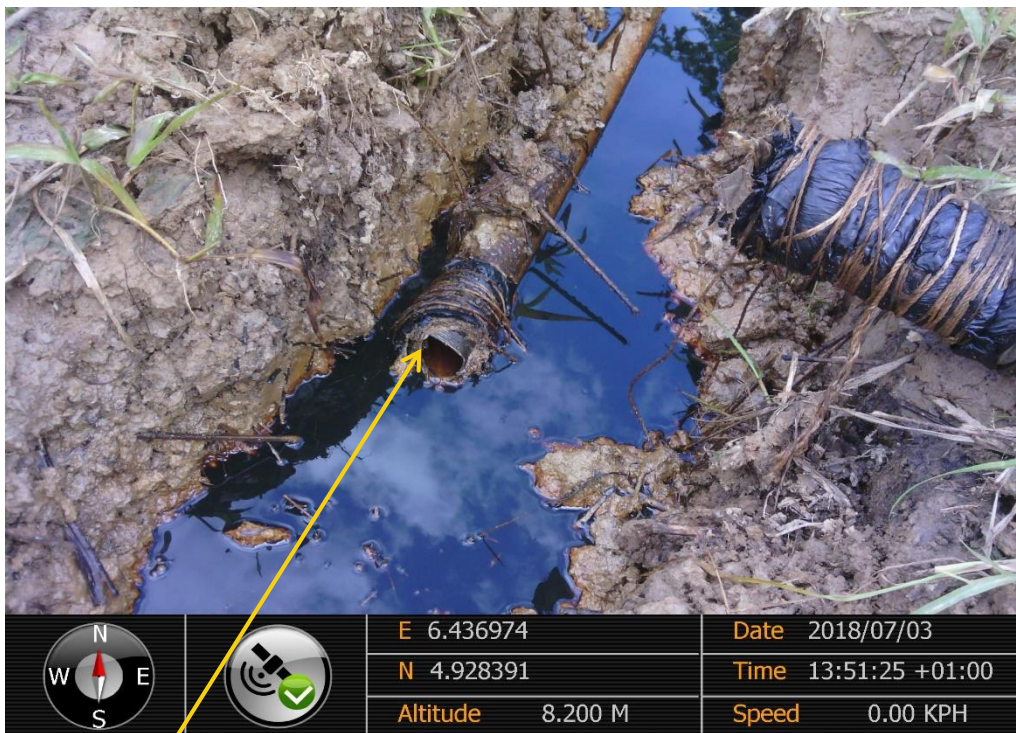
Close-up: Leak point from 2" pipe extension on 20" Kolocreek-Rumuekpe Pipeline at Odau KM9. Picture was taken during Joint Investigation of 3rd July 2018.

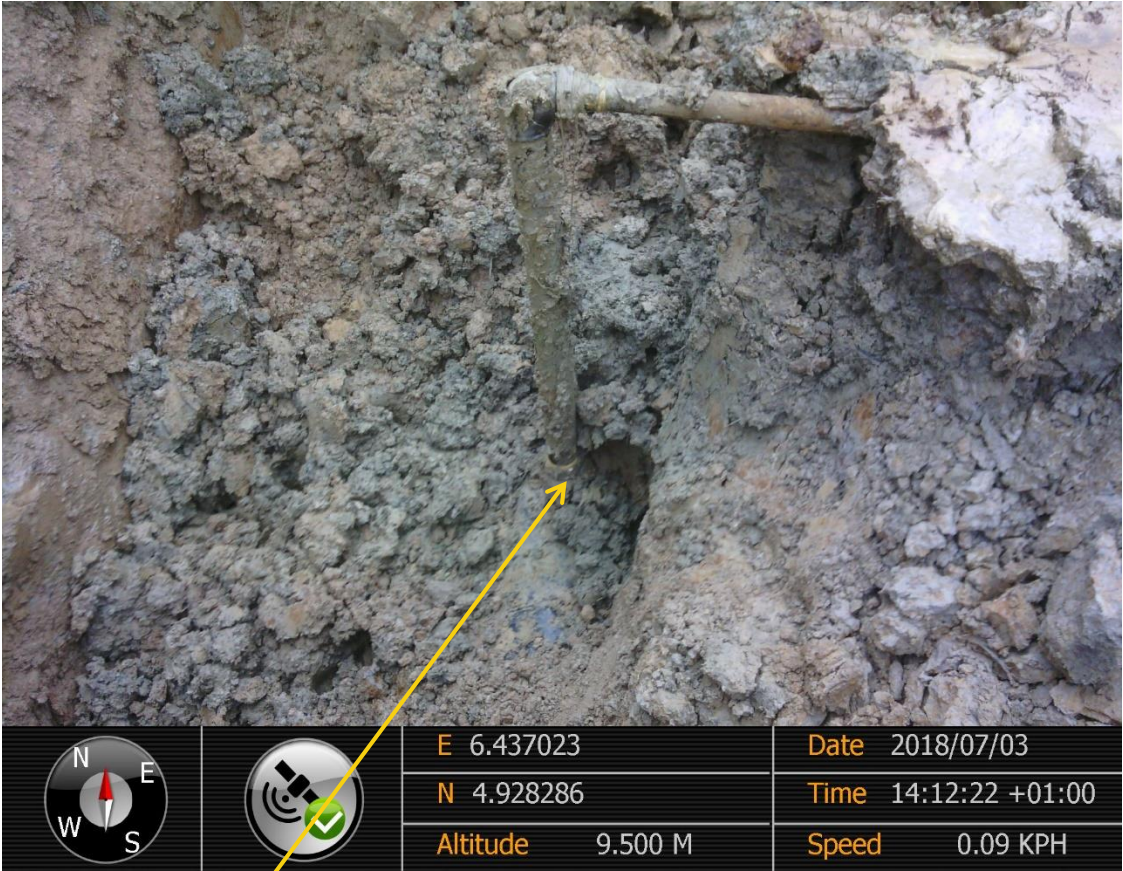
Close-up: Illegal Fitting on 20" Kolocreek-Rumuekpe Pipeline at Odau KM9. Picture was taken during Joint Investigation of 3rd July 2018.
