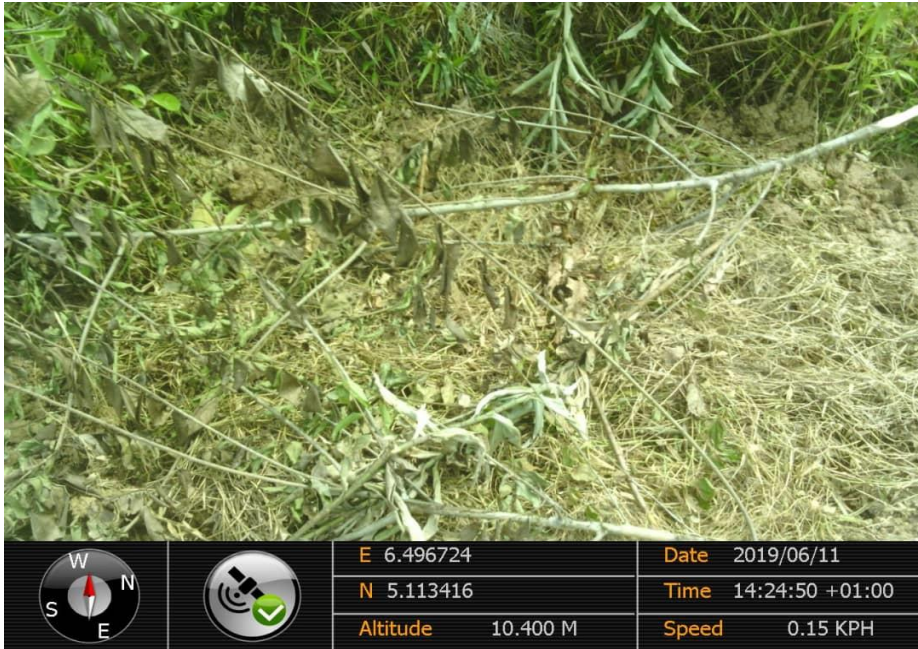
**Overview:** Part of spill impact on 14" Okordia-Rumuekpe Pipeline Right of Way at Akara-Olu. Picture was taken during Joint Investigation of 11<sup>th</sup> June 2019.

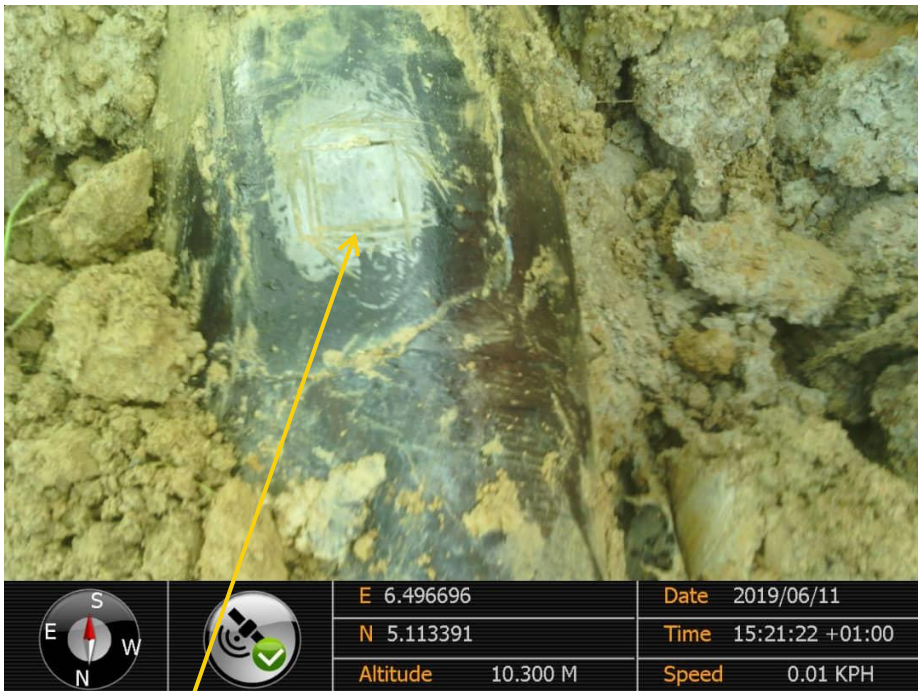
**Close-up:** Hack Saw Cut on 14" Okordia-Rumuekpe Pipeline at U Akara-Olu. Picture was taken during Joint Investigation of 11<sup>th</sup> June 2019.
