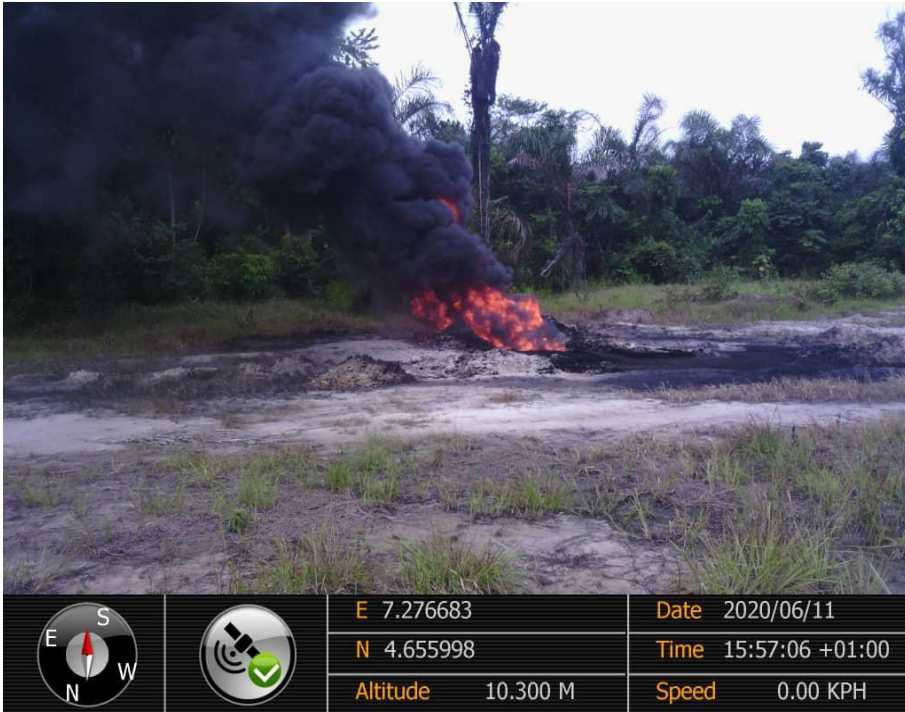
Overview: Part of spill impact on 28" Bomu Bonny Pipeline at Kpor. Picture was taken during Joint Investigation of 11th June 2020.

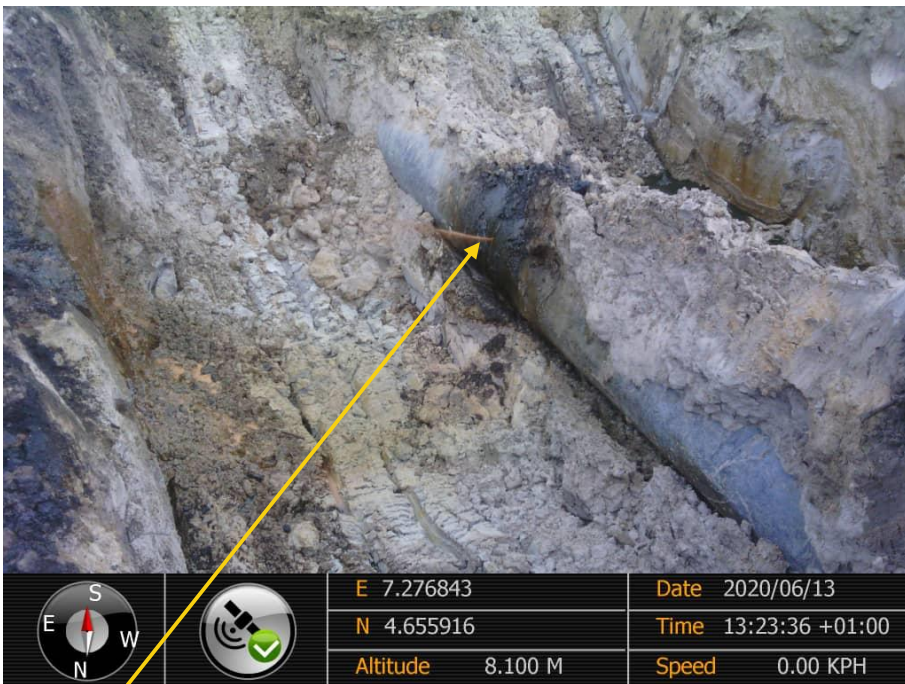
Close-up: Hack saw cut of 4m at 3 o'clock position on 28" Bomu Bonny Pipeline at Kpor. Picture was taken during Joint Investigation of 13th June 2020.
