Overview: Extent of the spill incident impact on 16" Egbema-Assa Pipeline at Assa . Pictures taken during Joint Investigation of 4th March, 2011

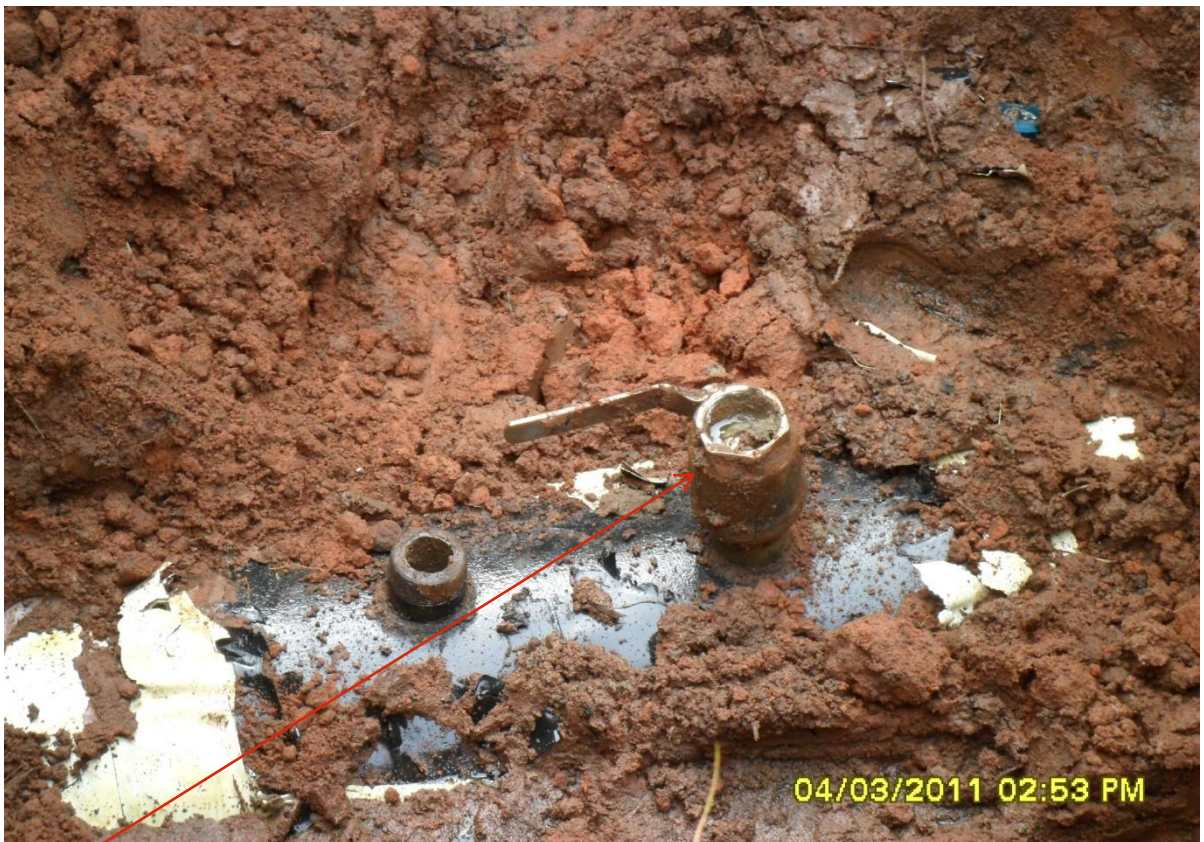
Close-up: Spill due to illegally welded points on 16" Egbema-Assa Pipeline at Assa. Picture taken during Joint Investigation of 4th March, 2011 .
