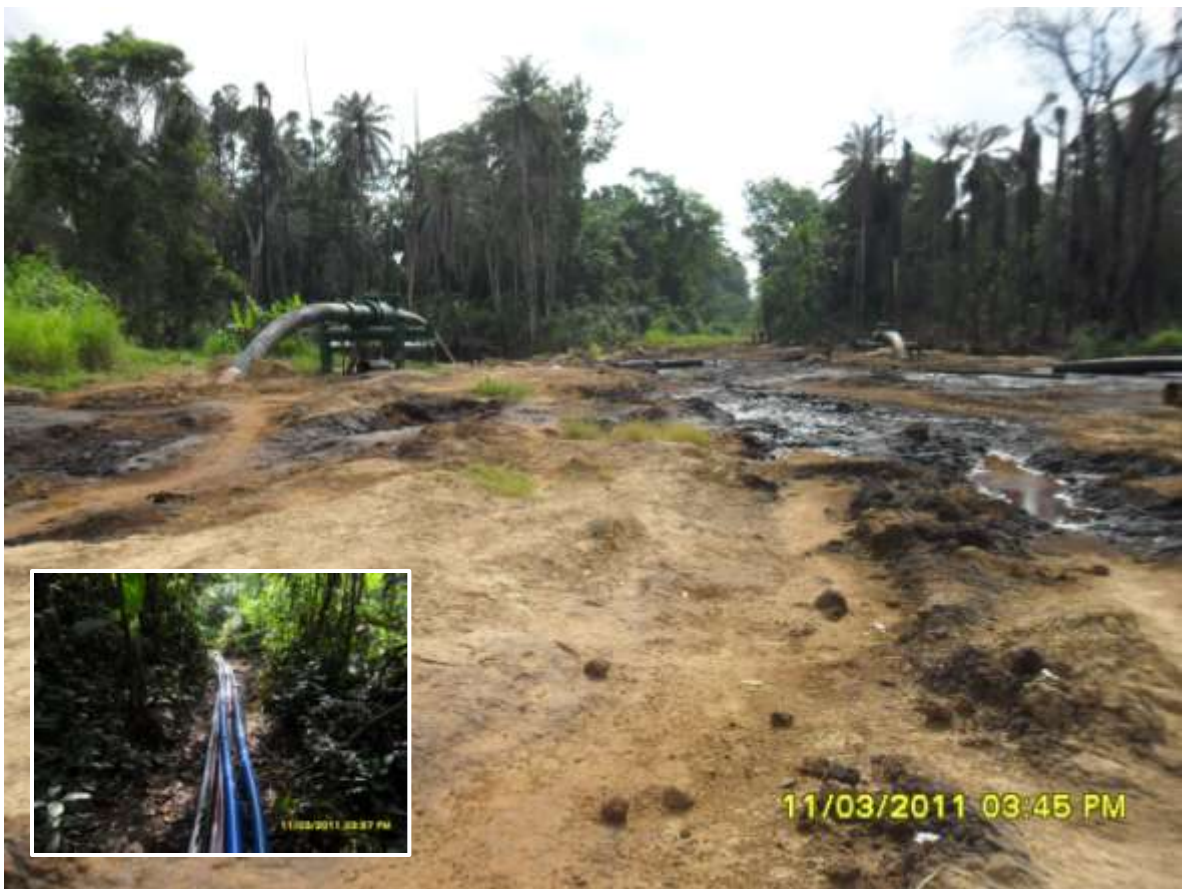
Overview: Extent of the spill incident impact at 20' Kolocreek-Rumuekpe Pipeline at Ogbogolo. Insert showing bunkering hoses from the site. Picture was taken during JIV of 11 March 2011

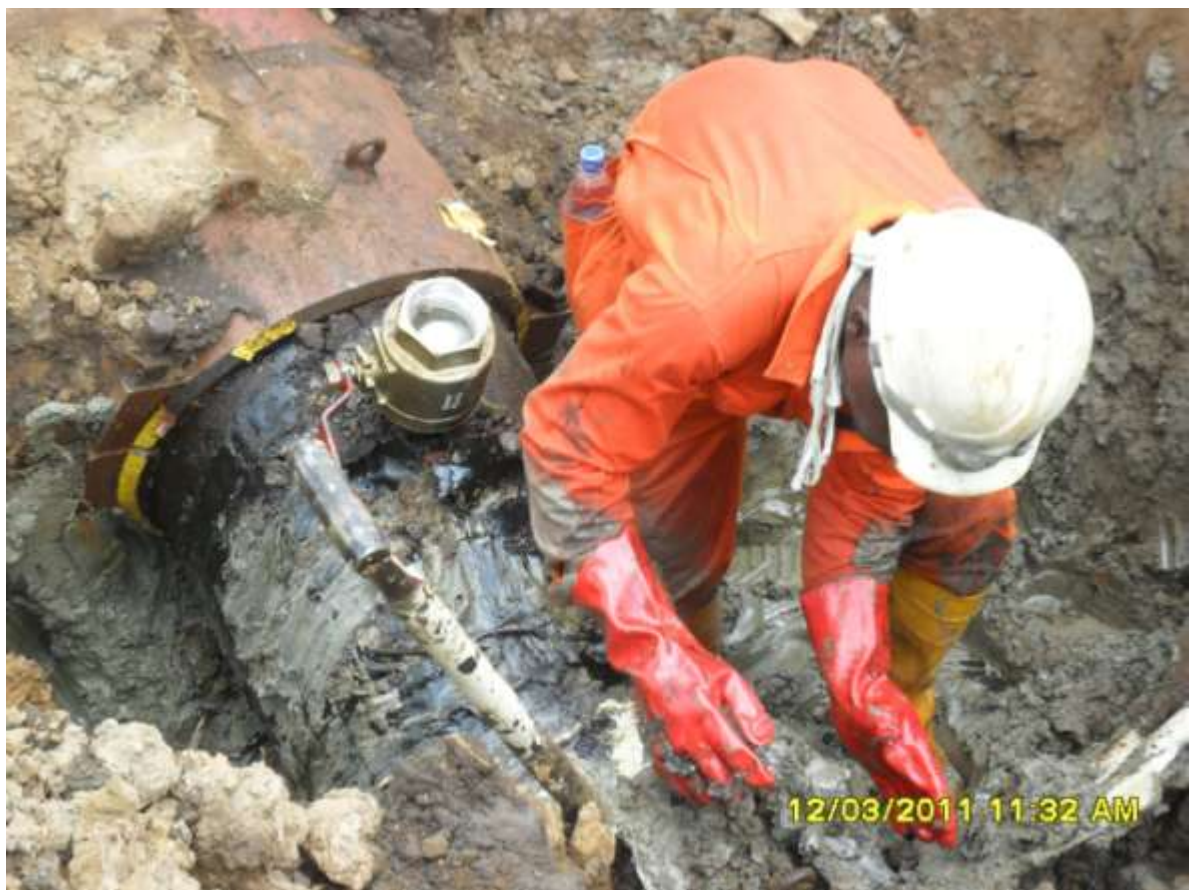
Close-up: Illegally welded point on 20' Kolocreek-Rumuekpe Pipeline at Ogbogolo. Picture was taken during JIV of 12 March 2011
