Overview: Extent of the spill incident impact on 8" Obigbo-North Pipeline at Obigbo .
Pictures taken during Joint Investigation of 25th March, 2011

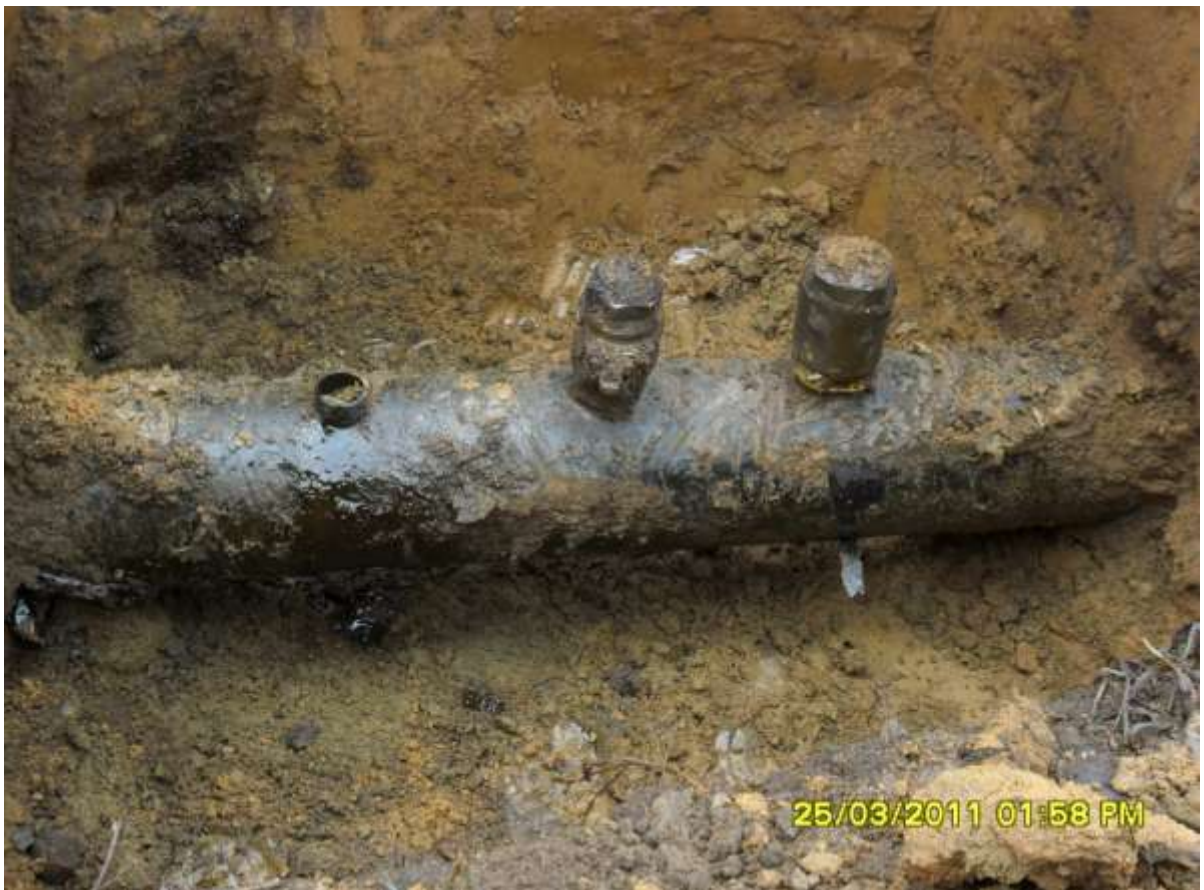
Close-up: Spill was due to illegally welded point on 8" Obigbo-North Pipeline at Obigbo.
Picture taken during Joint Investigation of 25th March, 2011.
