Overview: Extent of the spill incident impact on 24" Cawthorne channel-Bonny Block Valve Station pipeline route at Kalibiama .

Overview: Extent of the spill incident impact on 24" Alakiri-Bonny Pipeline route at Kalibiama. Pictures taken during Joint Investigation of 4th - 8th April, 2011

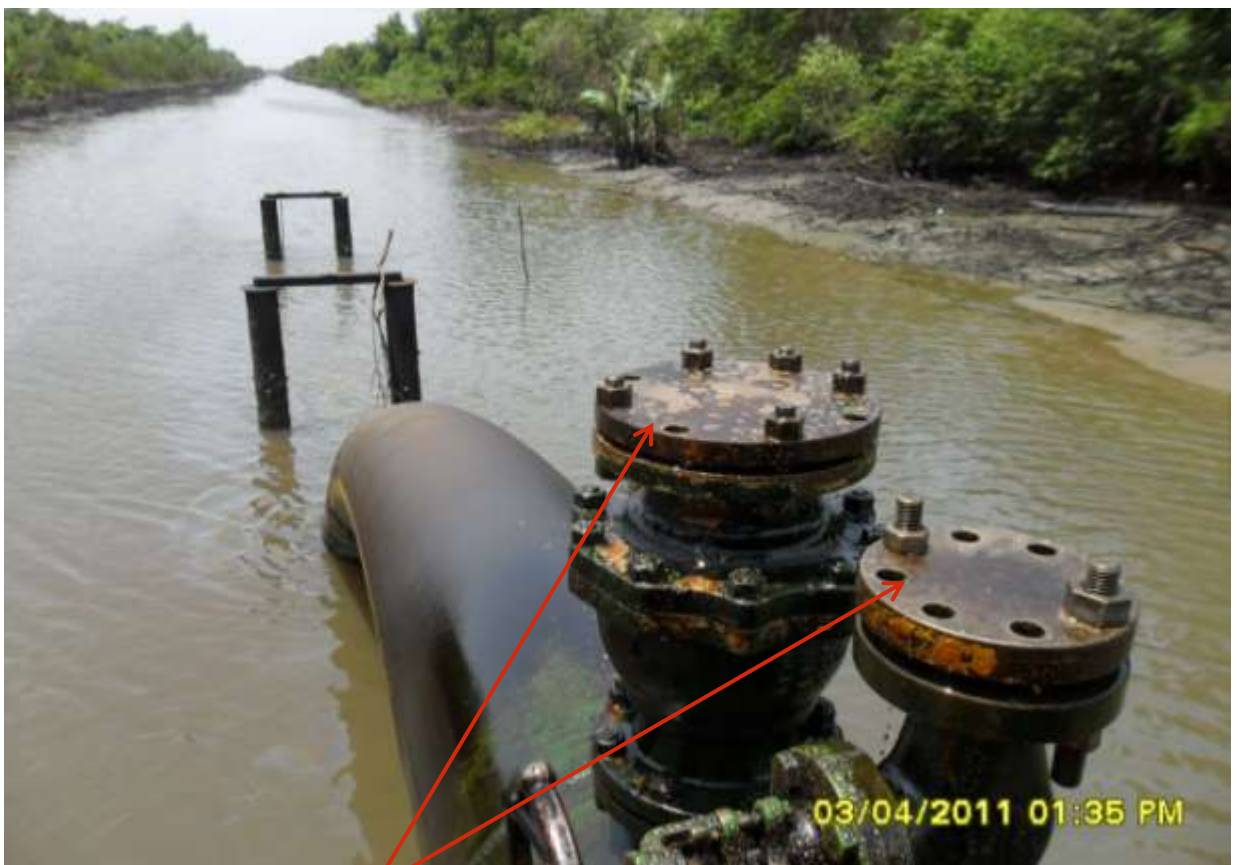
Close-up: Spill due to Tampering with flange nuts & bolts on 24" Cawthorne channel-Bonny Block Valve Station pipeline route at Kalibiama. Pictures taken during Joint Investigation of 1st- 3rd April, 2011

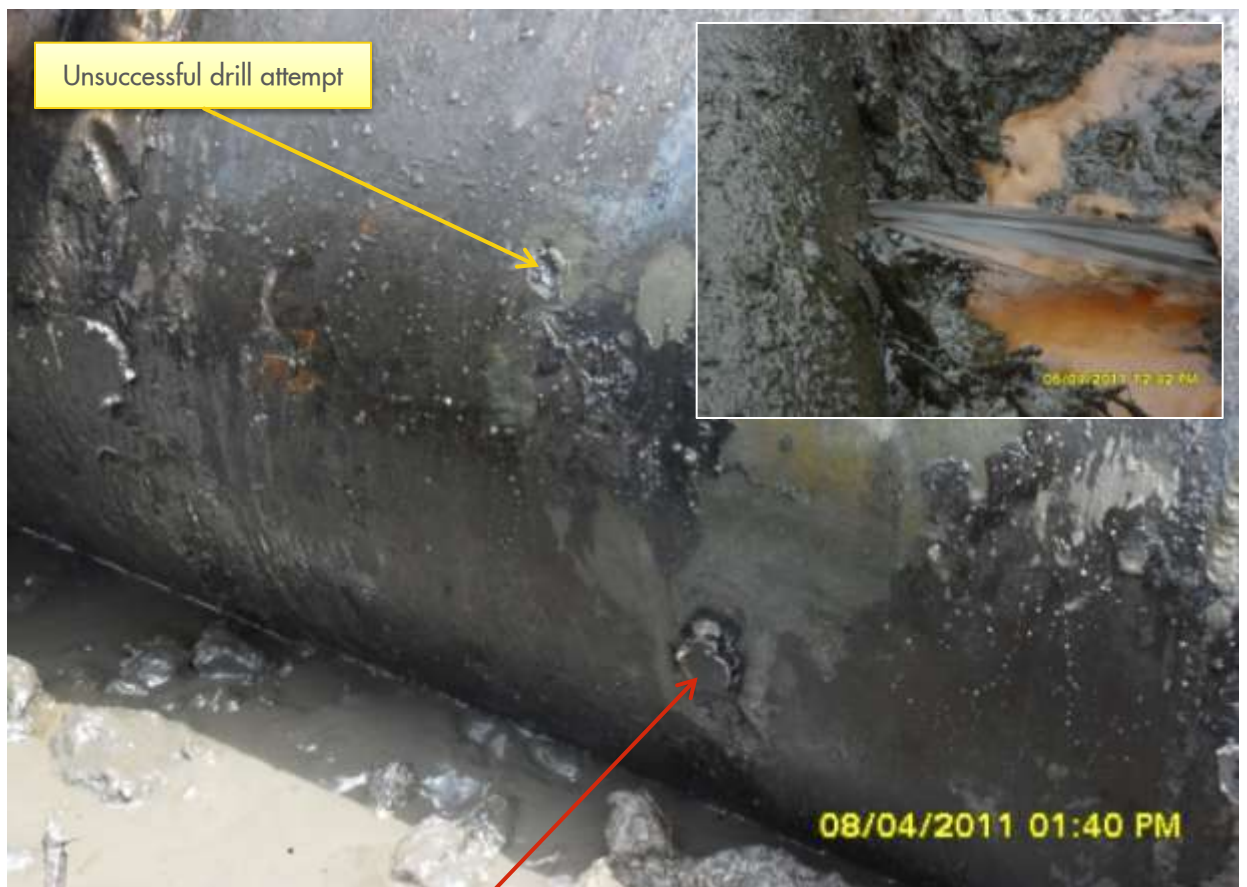
Close-up: Insert shows spill due to drilled hole on 24" Alakiri-Bonny pipeline route at Kalibiama. Main picture shows spill point after plugging. Unsuccessful drill attempt can also be seen.
