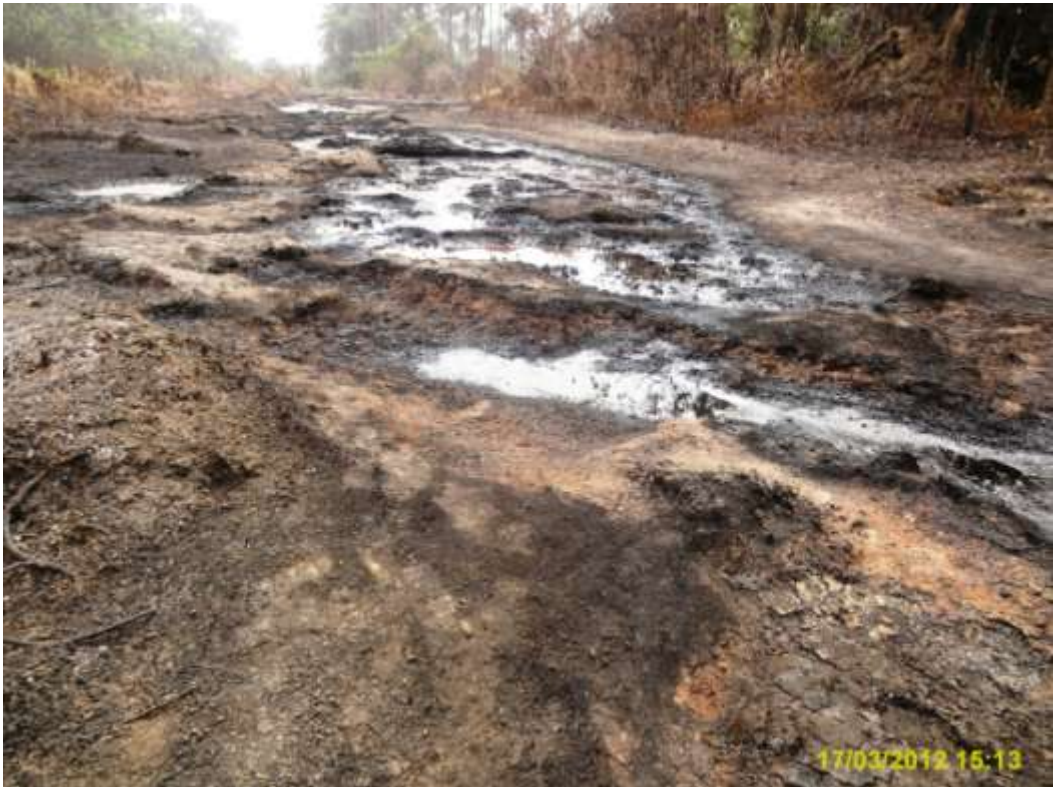
Overview: Part of spill impact on 16" Nun River – Kolo Creek trunkline right of way at Angiama-Gbeni. Picture was taken during Joint Investigation of 17th March 2012.

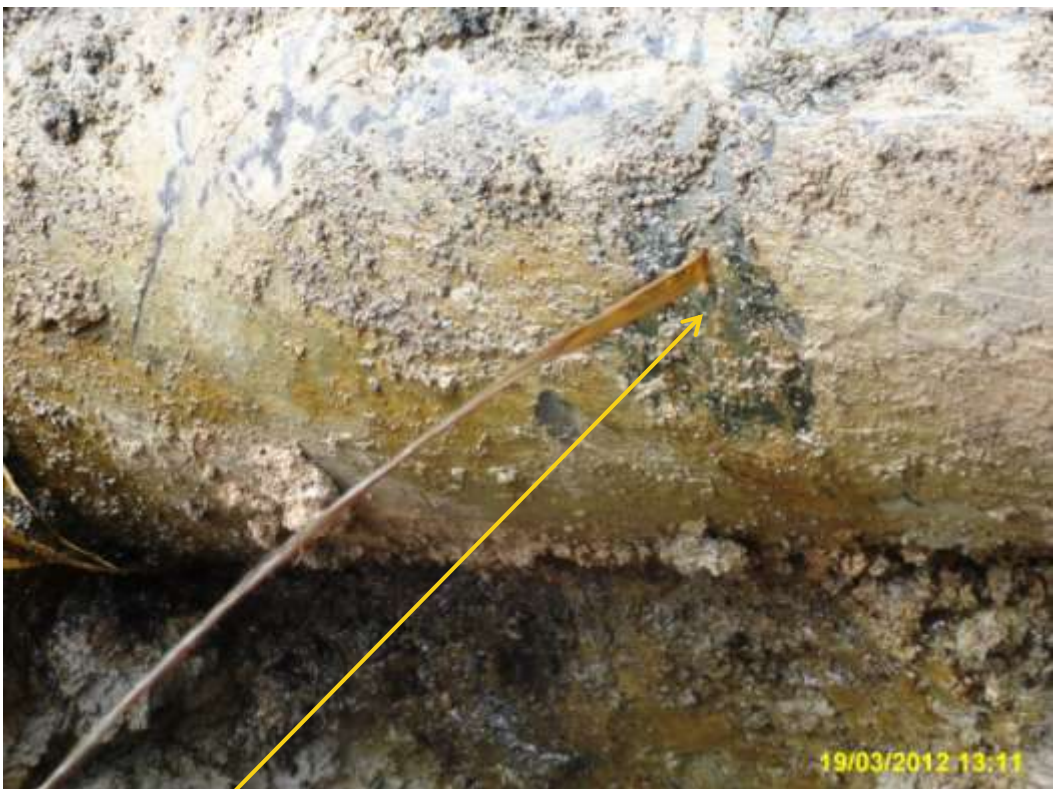
Close up: Hacksaw cut on 16" Nun River – Kolo Creek trunkline at Angiama-Gbeni. Picture was taken during Joint Investigation of 19th March 2012.
