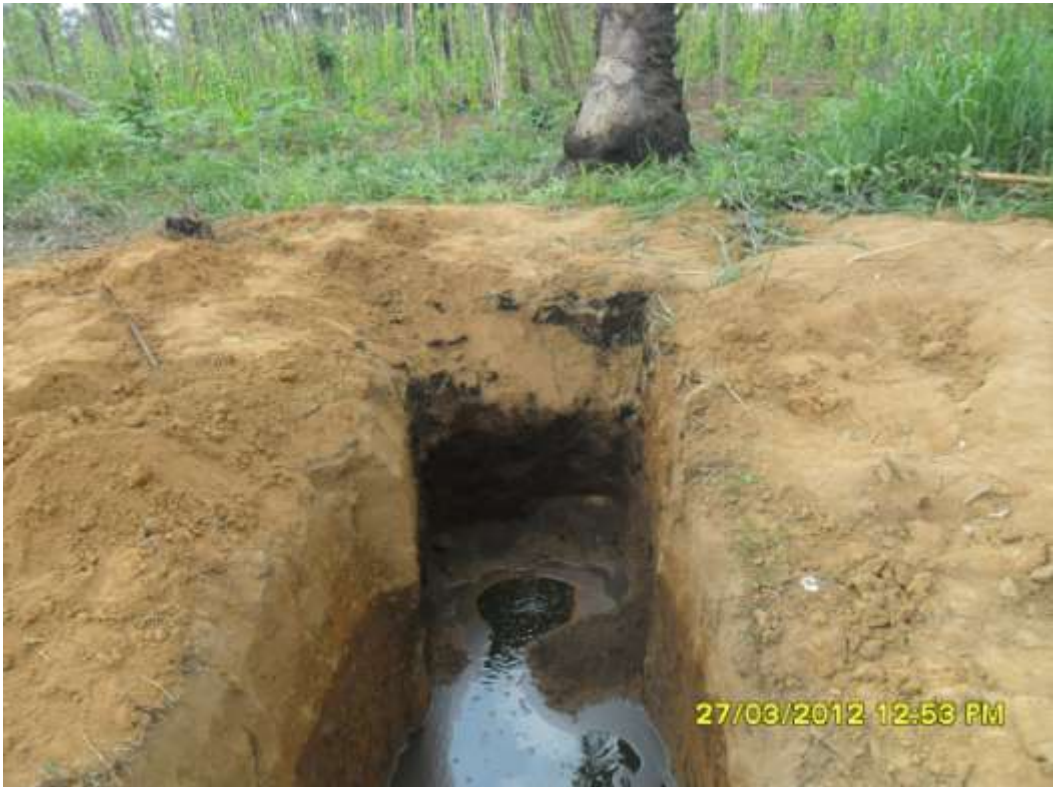
Overview: Part of spill impact on 24" Nkpoku-Bomu pipeline right of way at Bera.
Picture was taken during Joint Investigation of 27th March 2012.

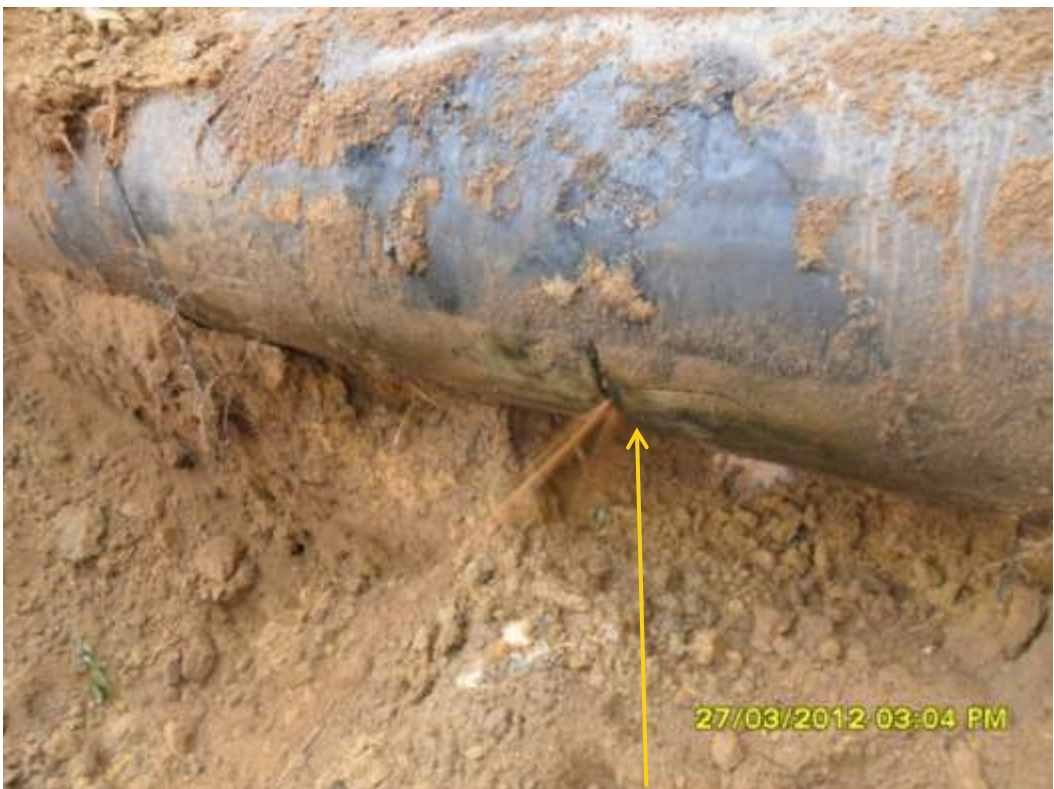
Close up: Hacksaw cut on 24" Nkpoku-Bomu pipeline at Bera. Picture was taken during Joint Investigation of 27th March 2012.
