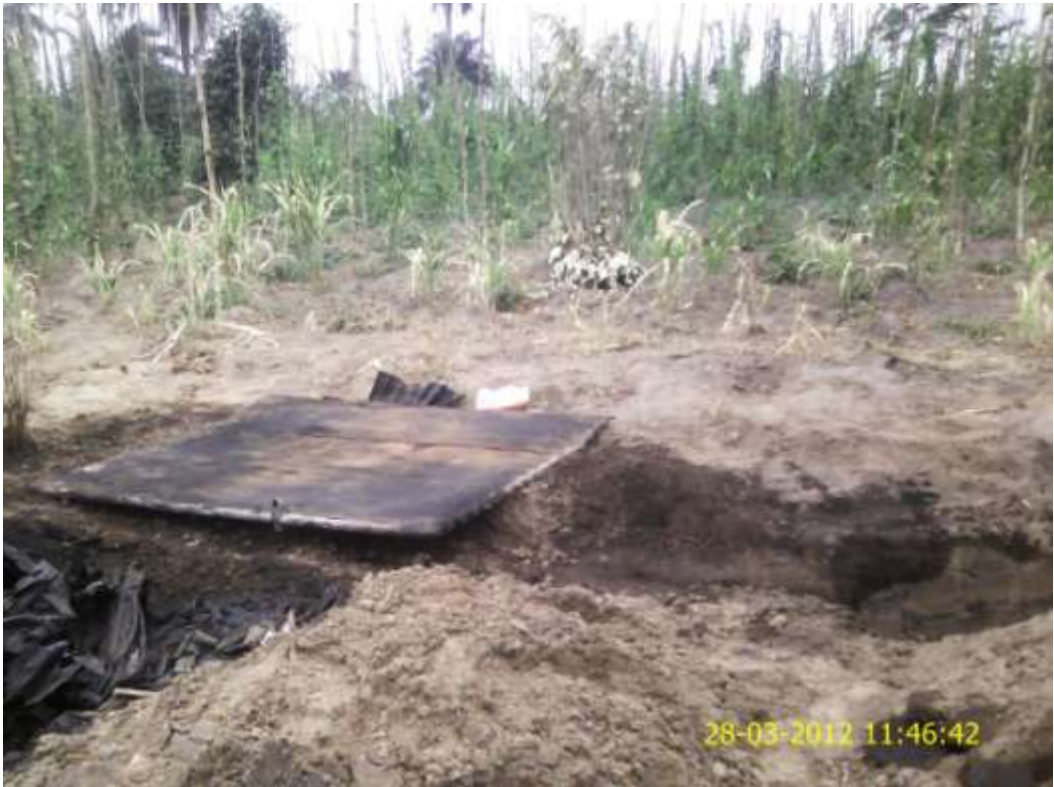
Overview: Part of spill impact on 24" Bomu-Bonny pipeline right of way at Mogho. Picture was taken during Joint Investigation of 28<sup>th</sup> March 2012.

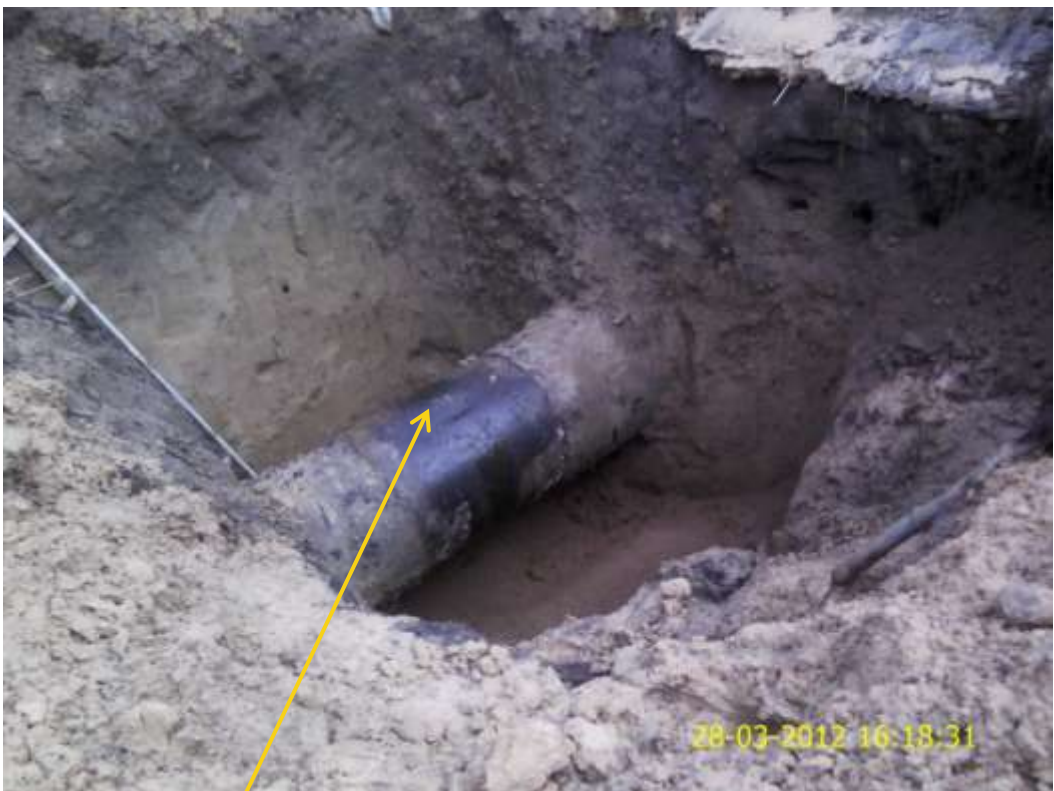
Close up: Hacksaw cut on 24" Bomu-Bonny pipeline at Mogho. Picture was taken during Joint Investigation of 28<sup>th</sup> March 2012.
