JOINT INVESTIGATION REPORT

INCIDENT NO: 2042268 JIV report S/N: 1041

1. Spill incident Number: 2042268 2. Type of incident* OIL SPILL
3. Name of Location 20" KOLOCREEK - RUMUGKPE (TRUNKLINE) PIPELINE
4. Name of nearest community ODAM (KM 19) 5. State: RIVERS 6. LGA ABUA/ODUAL
7. Type of Production facility/Installation OIL PIPELINE
8. Asset owner/District THE SHELL PETROLEUM DEVELOPMENT COMPANY OF NIGERIA LIMITED PIPELINE

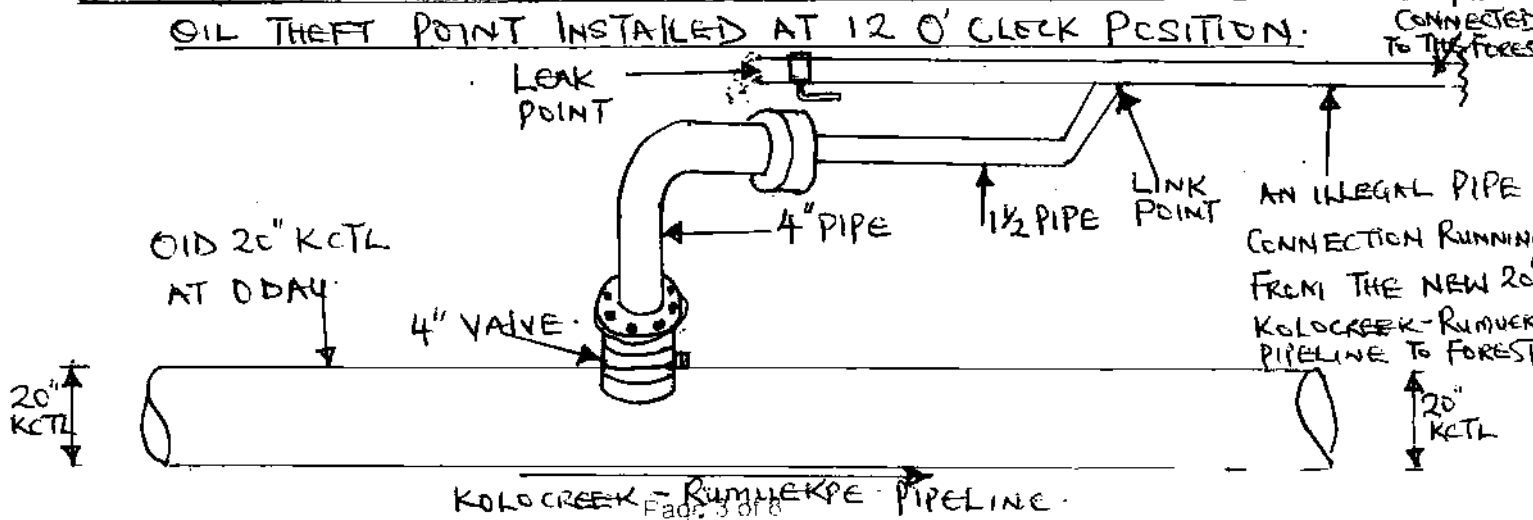
Additional observations around the spill point: AN ILLEGAL 1/2" PIPE CONNECTION WAS OBSERVED RUNNING FROM THE SPILL VALVE INTO THE SURROUNDING FOREST, WHERE IT IS LINKED TO ANOTHER ILLEGAL PIPE CONNECTION RUNNING FROM THE NEW 20" KCTL INTO THE FOREST.

SECTIONAL VIEW OF 20" KOLOCREEK - RUMUEKPE (TRUNKLINE) PIPELINE AT

ODAY (KM 19) SHOWING: ONE (1) NO 4" REDUCES TO 1 1/2" CRUDE PIPE OIL THEFT POINT INSTALLED AT 12 O' CLOCK POSITION:

TEMPORARY REPAIR BY BLIND-FLANGING WAS DONE AND A RESTRICTION FITTING WAS INSTALLED AT THE CRUDE OIL TIGHT POINT.
