JOINT INVESTIGATION REPORT

INCIDENT NO: 2594252 JIV report S/N: 0566

1. Fountain Incident Number: 2594252 2. Type of incident* OIL SPILL
3. Name of Location OBELE FLOW STATION
4. Name of nearest community OBELE 5. State: RIVER 6. LGA EMOLGA
7. Production Facility/Installation FLOW STATION
8. Asset Owner/Hub THE SHELL PETROLEUM DEVELOPMENT COMPANY OF NIGERIA LIMITED (SPDC)/LAND EAST HUB

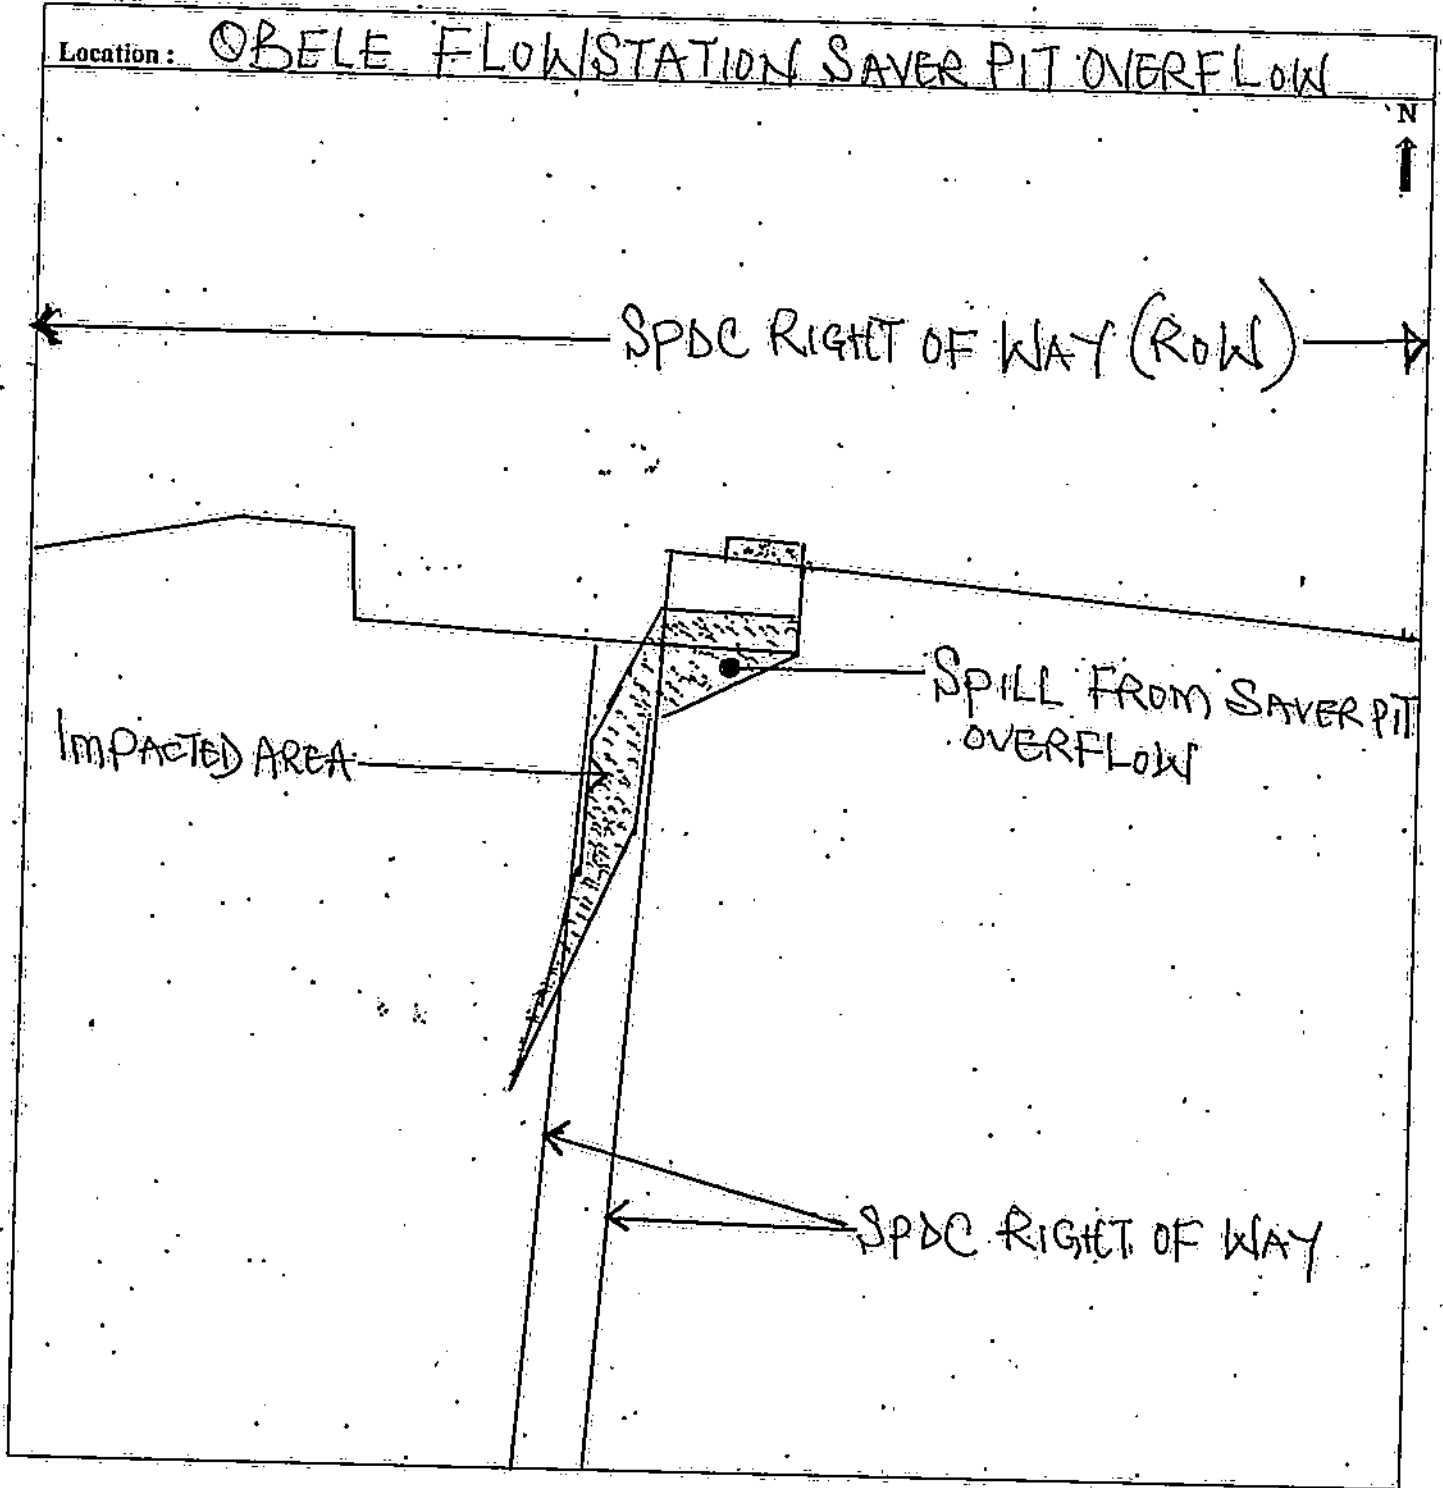
f. Appendix 1: Overview sketch of the site

E. GRAPHIC DESCRIPTION OF LEAK POINT (while detailed description of the leak point should be contained in the leak report, overview sketch of the site should be added as appendix 1) A SECTION OF OBELE FLOW STATION SAVER PIT SHOWING OVERFLOWN SAVER PIT DUE TO HEAVY RAINFALL.

OVERFLOWN SAVER PIT

i. Joint investigation of the incident site found that there is no residual impact after the initial response and JIV therefore recommend that the site be closed out <input type="checkbox"/>
ii. Investigation of the incident site showed that there is residual impact on site requiring further works <input checked="" type="checkbox"/>
