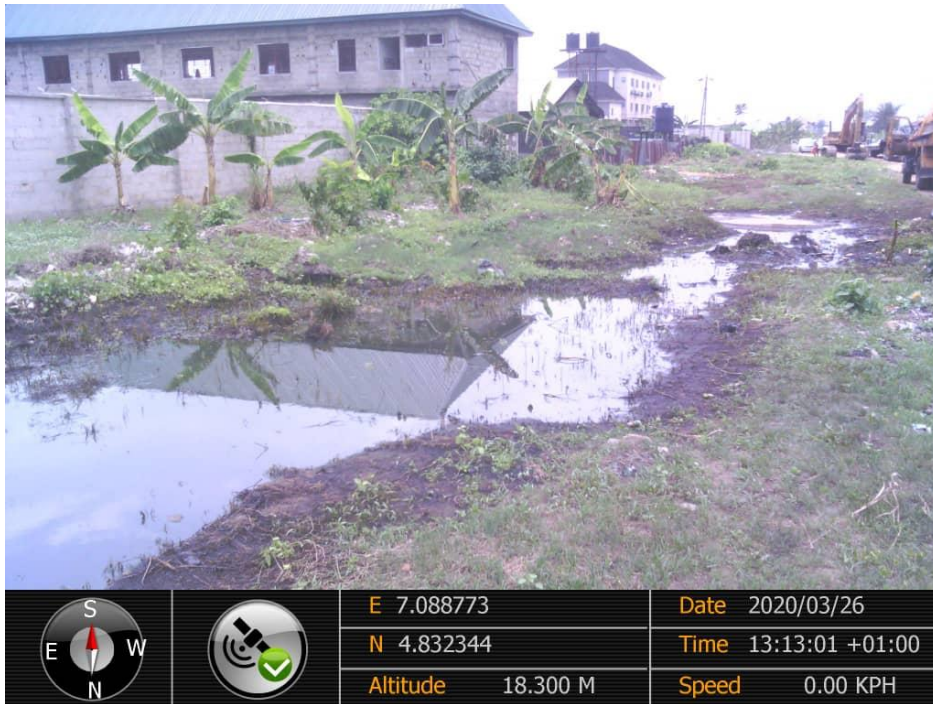
Overview: Part of spill impact on 28'' Nkpoku - bomu Pipeline at Akpajo. Picture was taken during Joint Investigation of 26th March 2020.

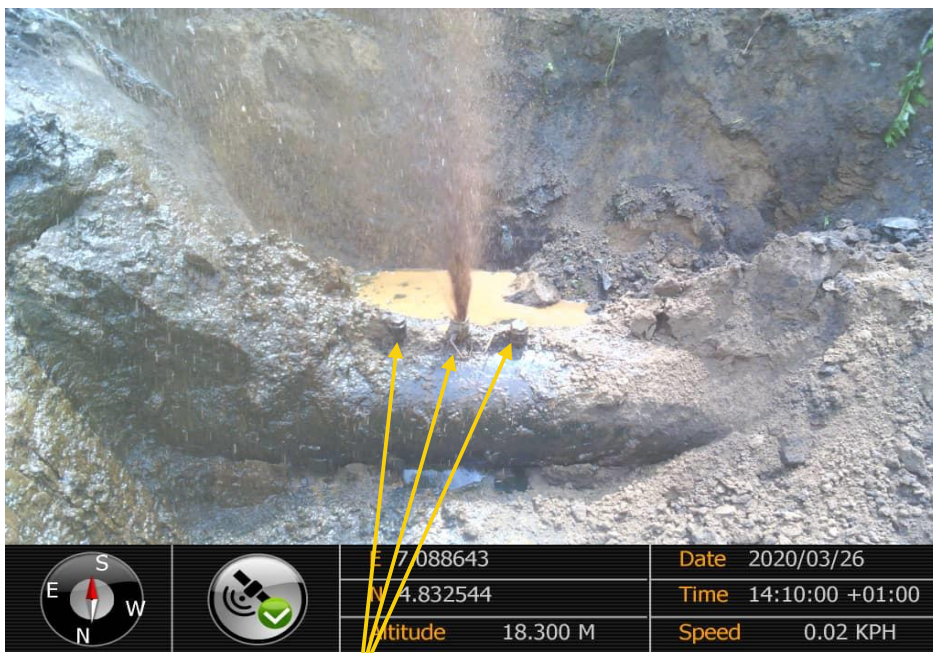
Close-up: 2'' valve crude oil theft points installed at 12 o'clock position on 28'' Nkpoku - Bomu Pipeline at Akpajo. Picture was taken during Joint Investigation of 26th March 2020.
