# JOINT INVESTIGATION REPORT

INCIDENT NO: 2613155 JIV report S/N: 0472

1. Fountain Incident Number: 2613155 2. Type of incident\* OIL SPILL  
3. Name of Location 16" EGBEMA-ASSA PIPELINE AT UMUDIKE  
4. Name of nearest community UMUDIKE 5. State: IMO 6. LGA EGBEMA-OKAJI  
7. Production Facility/Installation CRUDE OIL PIPELINE  
8. Asset Owner/Hub THE SHELL PETROLEUM DEVELOPMENT COMPANY OF NIGERIA LIMITED (SPDC)/PIPELINE

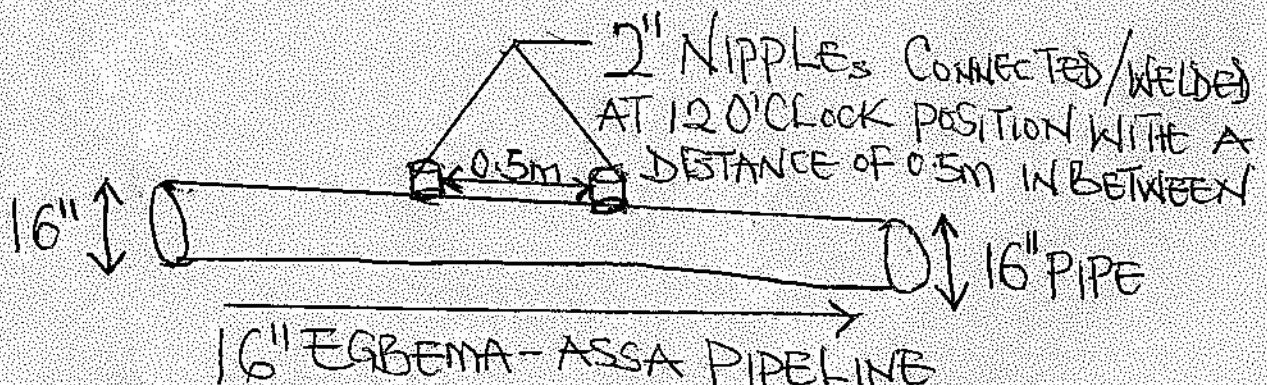
**E. GRAPHIC DESCRIPTION OF LEAK POINT** (while detailed description of the leak point should be contained in the leak report, overview sketch of the site should be added as appendix 1) A SECTION OF 16" EGBEMA-ASSA PIPELINE AT UMUDIKE SHOWING TWO (2) NOS 2" NIPPLE INSTALLED 0.5M APART AT 12 O'CLOCK POSITION BY UNKNOWN PERSON(S).

CLAMPING AND SPILL RESPONSE IN PROGRESS
