Overview: Part of spill impact on 4" Etelebou Well 1S Flowline at Ogboloma. Picture was taken during Joint Investigation of 18th March 2020.

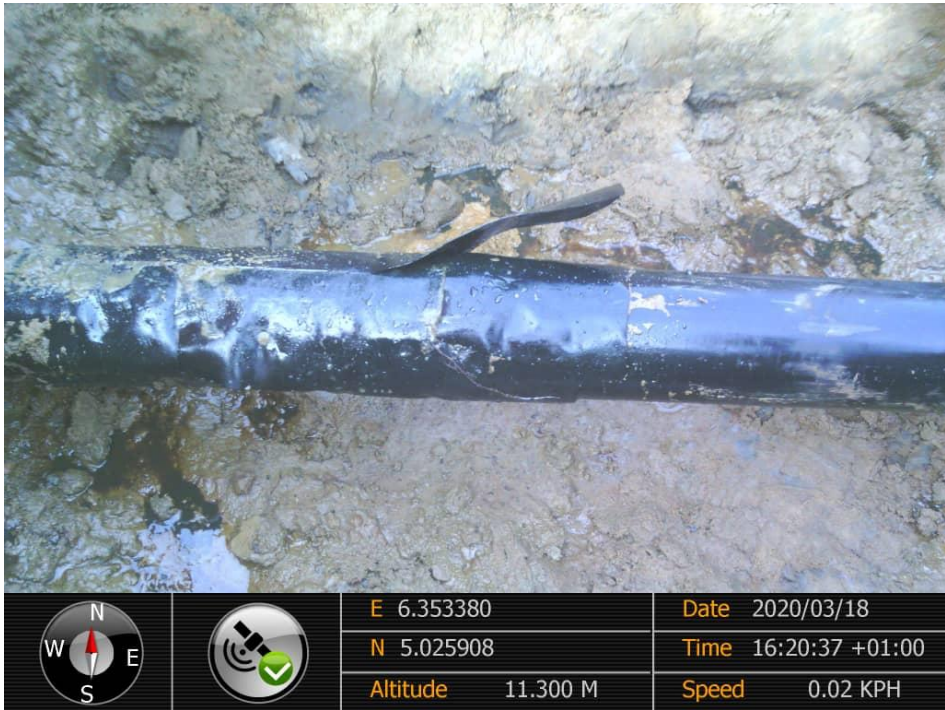
Close-up: 4" Etelebou Well 1S Flowline at Ogboloma. Picture was taken during Joint Investigation of 18th March 2020.

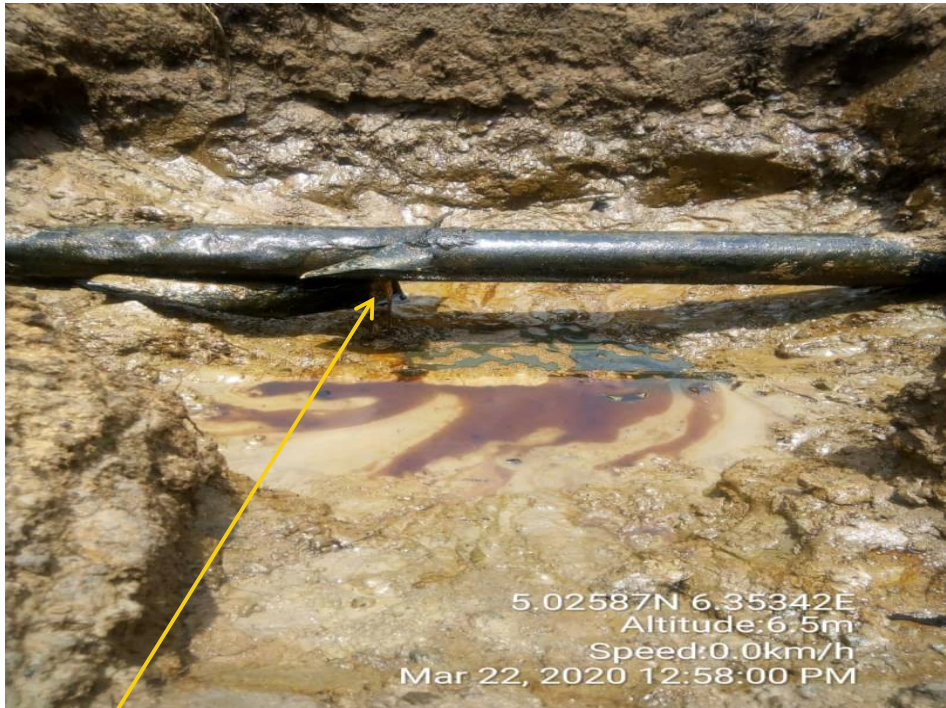
Close-up: Pen size hole at 6 O'clock position on 4" Etelebou Well 1S Flowline at Ogboloma.
Picture was taken during Post visit of
22nd March 2020.
