Overview: Part of spill impact on NunRiver Well 13T Well head at Angiama. Picture was taken during Joint Investigation of 28<sup>th</sup> March 2020.

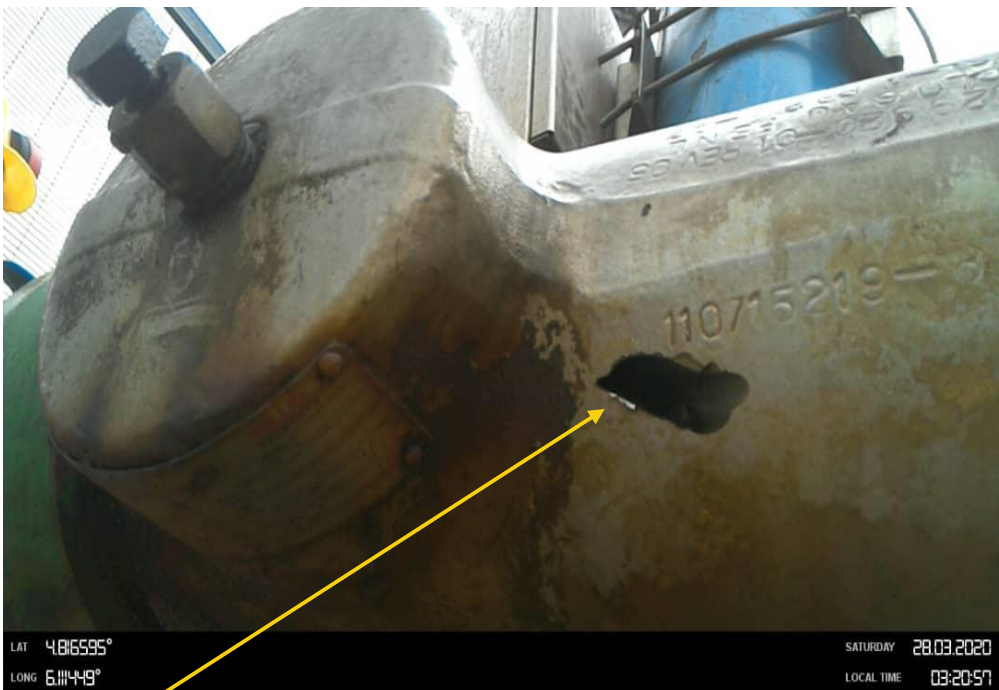
Close-up: Erosion on bean box on NunRiver Well 13T Well head at Angiama. Picture was taken during Joint Investigation of 28<sup>th</sup> March 2020.
