Overview: Part of spill impact on 12" Oguta-Egbema pipeline right of way at Obiakpu. Picture was taken during Joint Investigation of 22nd May 2013.

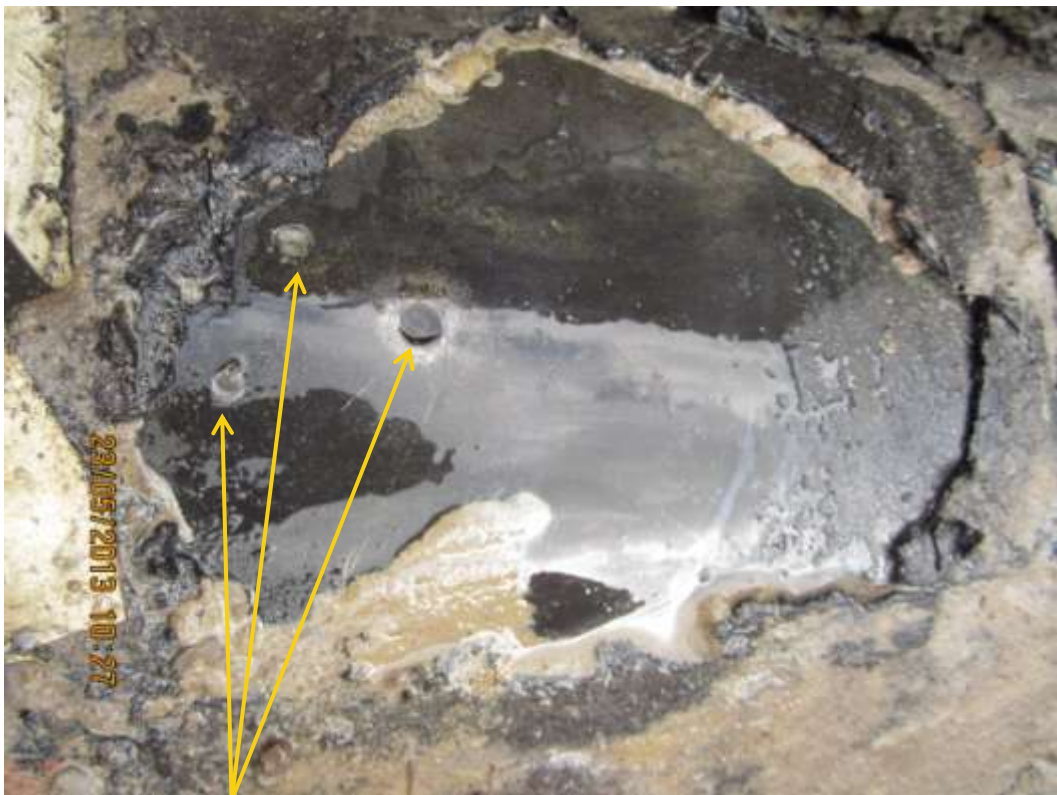
Close up: Drilled holes on 12" Oguta-Egbema pipeline at Obiakpu. Picture was taken during Joint Investigation of 23rd May 2013.
