JOINT INVESTIGATION REPORT

1. Spill incident Number: 1393731 2. Type of incident* OIL SPILL
3. Name of Location AGBADA 2 WELL 34S FLOWLINE
4. Name of nearest community OMUOHIA 5. State: RIVERS 6. LGA IKWERRE
7. Type of Production facility/Installation OIL FLOWLINE
8. Asset owner/District LAND 1

9. Details of incident
a. Date of incident: 2ND MAY, 2015
b. Start date/time of investigation: 3RD MAY, 2015/13:42 HOURS
c. Investigation End date: 3RD MAY, 2015 Actual investigation duration, days: ONE (1) DAY
d. Description of spill point environment

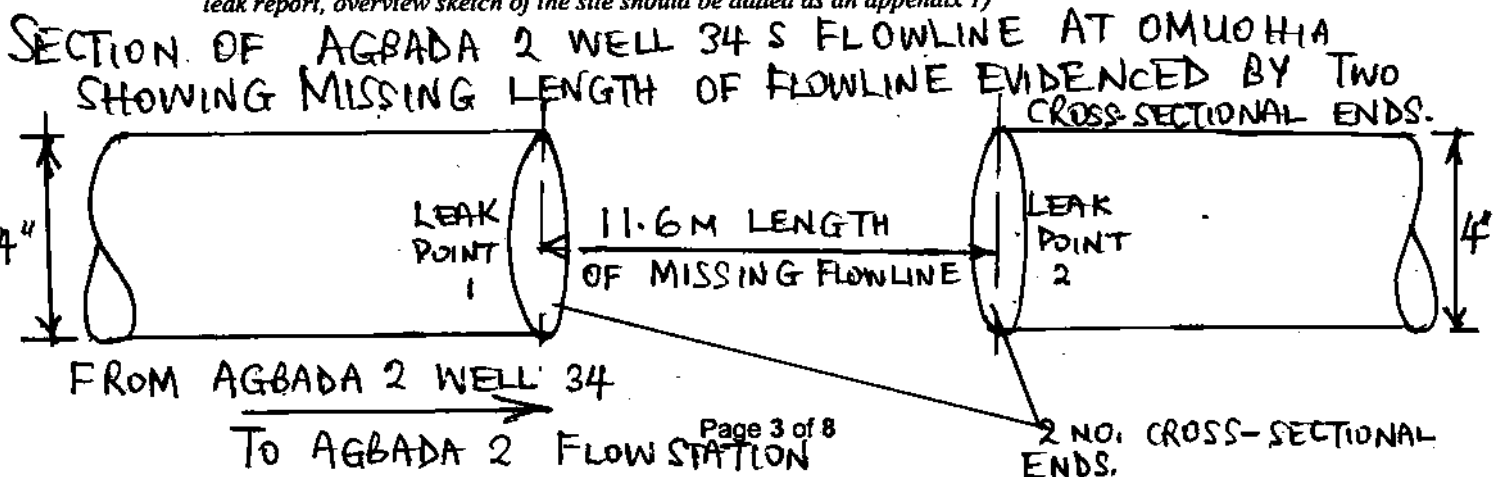
E. GRAPHIC DESCRIPTION OF LEAK POINT (while detail report of the leak point should be contained in the leak report, overview sketch of the site should be added as an appendix 1)

Additional observations around the spill point: ON ARRIVAL AT SITE, THE JOINT INVESTIGATION TEAM OBSERVED TWO CROSS-SECTIONAL ENDS OF A MISSING LENGTH (APPROXIMATELY 11.6 METRES) OF THE 4" WELL 34S FLOWLINE. A CUTTING DISC, LEFT ON SITE BY UNKNOWN PERSON(S), WAS OBSERVED BESIDE THE SPILL-IMPACTED AREA. PICTURES OF SOME CUT SECTIONS OF THE FLOWLINE AND DISUSED HACK SAWS LEFT BY UNKNOWN PERSON(S) WERE SHOWN TO THE TEAM.

| <input type="checkbox"/> Failed Weld-on illegal hot tap valve | <input type="checkbox"/> Failed Clamp, | <input checked="" type="checkbox"/> Missing Pipeline/Flowline |

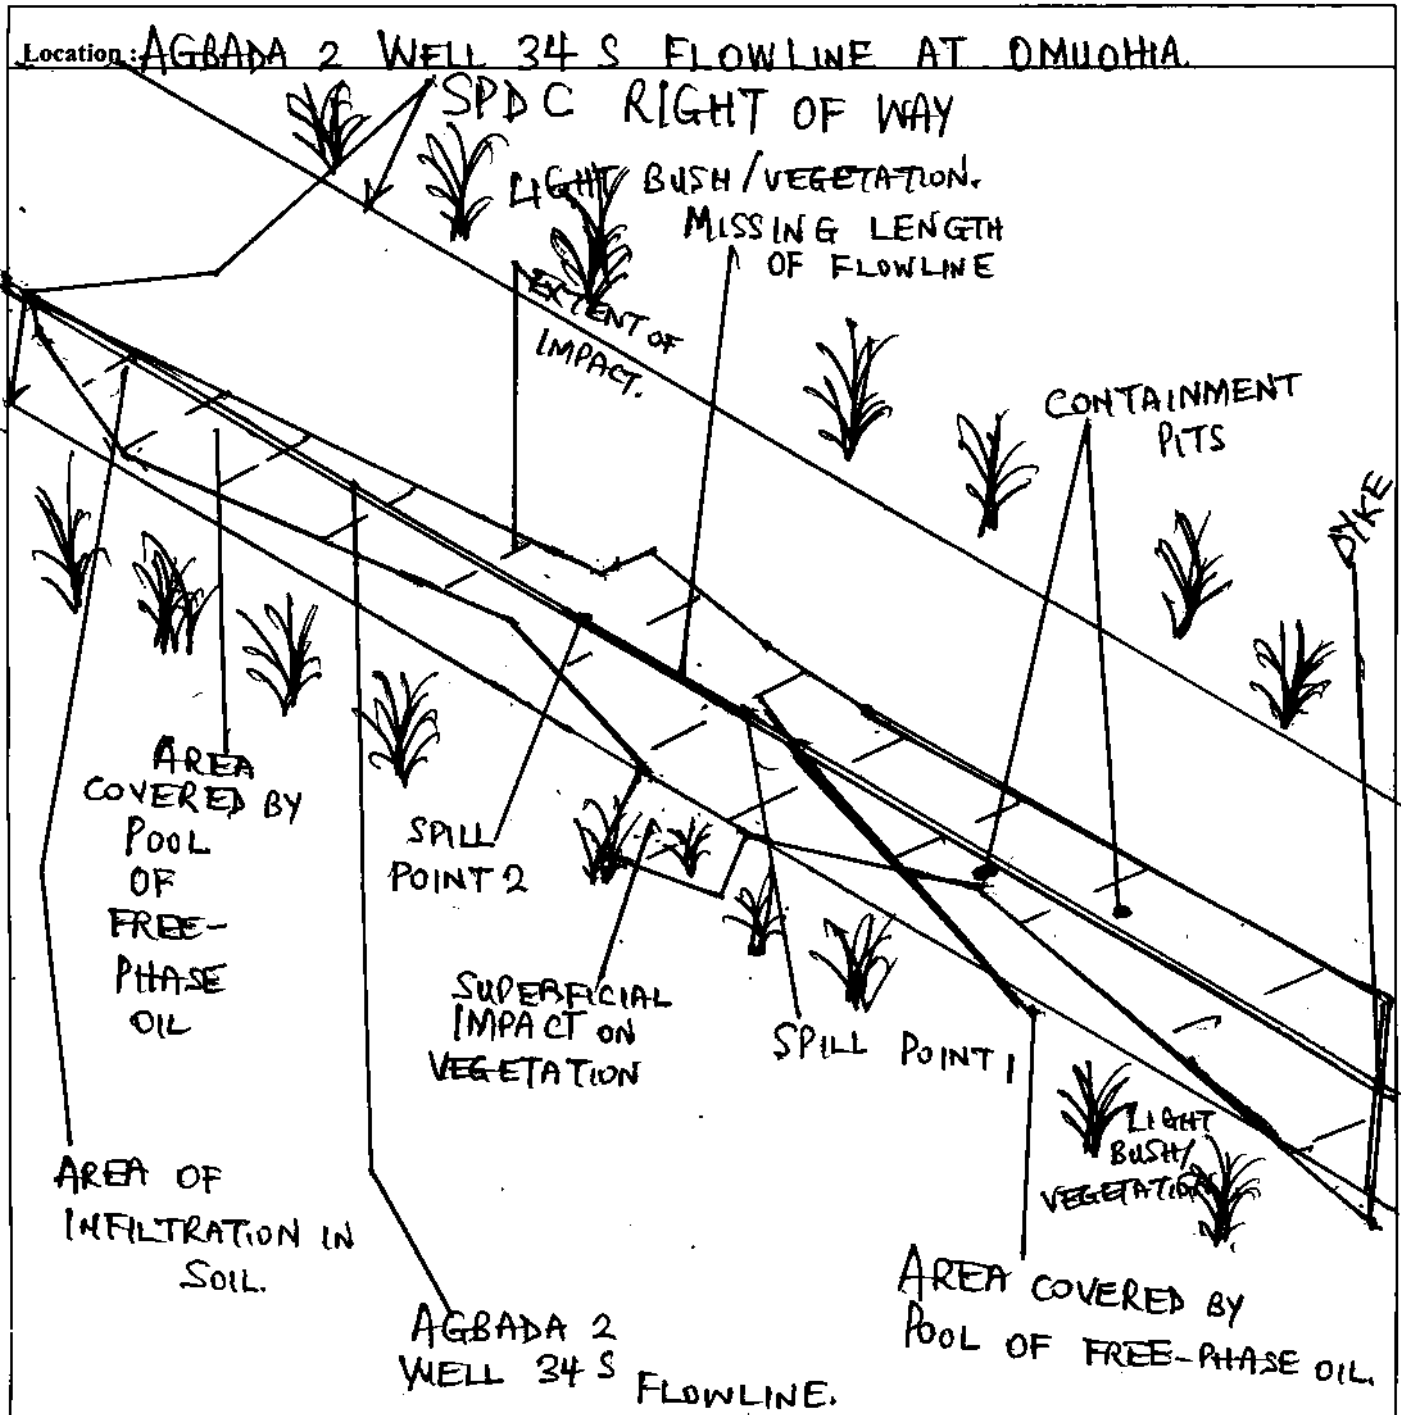
f. Appendix 1: Overview sketch of the site

- Total calculated area of impact 0.0764Ha
- Impact within R.O.W YES
- Impact outside R.O.W YES
